# The Case of the Lakewood "Hi-Stak"

Failure of a Stacking Hoist

Interoffice Memorandum  
Buchanan Dies, Inc.  
Facility: EAST PEORIA  
Date June 22, 1994  
Department: Plant Engineering - KK- 1

Subject: ACCIDENT INVESTIGATION - Building HH:20E

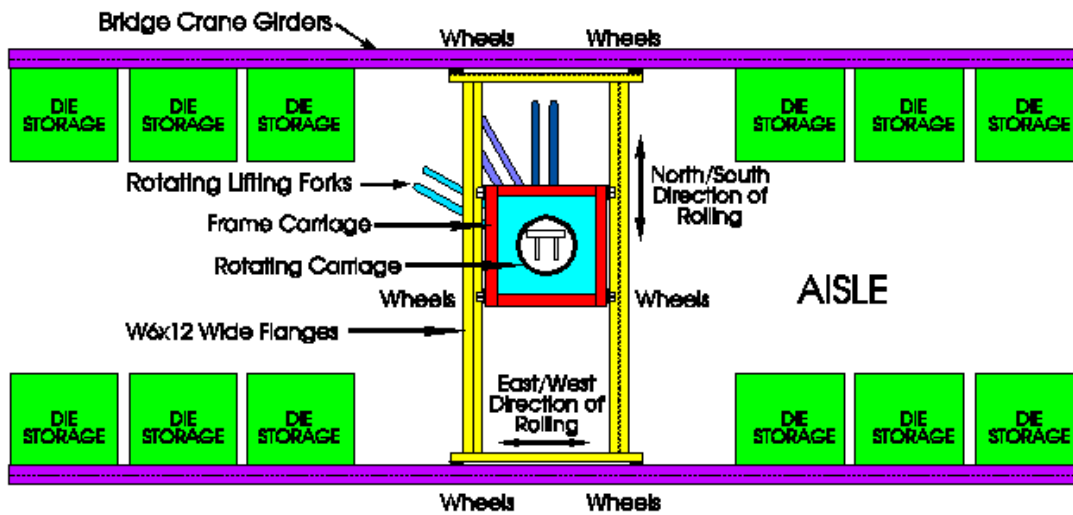
Figure 1

The Lakewood Company, a fairly large manufacturing firm, has designed, manufactured and sold hundreds of self-contained storage/retrieval systems which are used for storing heavy parts such as dies, which must intermittently be taken from storage and used elsewhere in the plant. The system consists of two large sets of storage racks, facing each other, with an integral crane that runs between them on 2 bridge crane girders on the top back edges of the storage racks (see Figure 1).

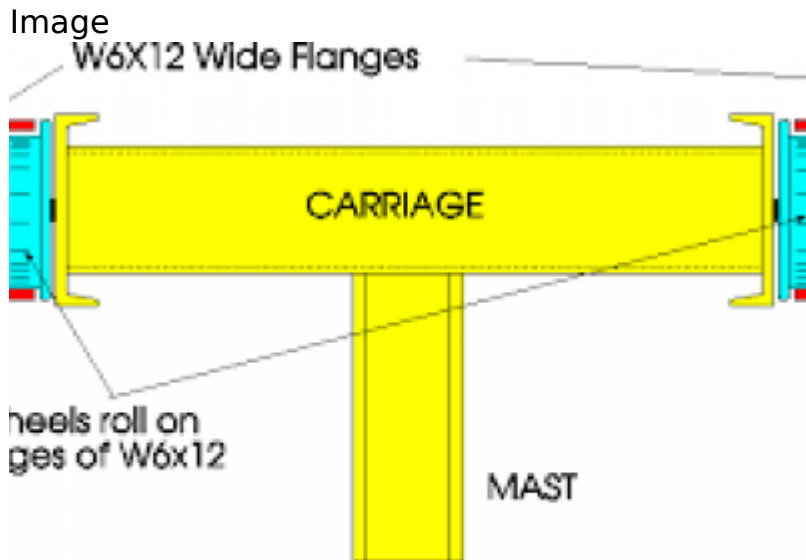
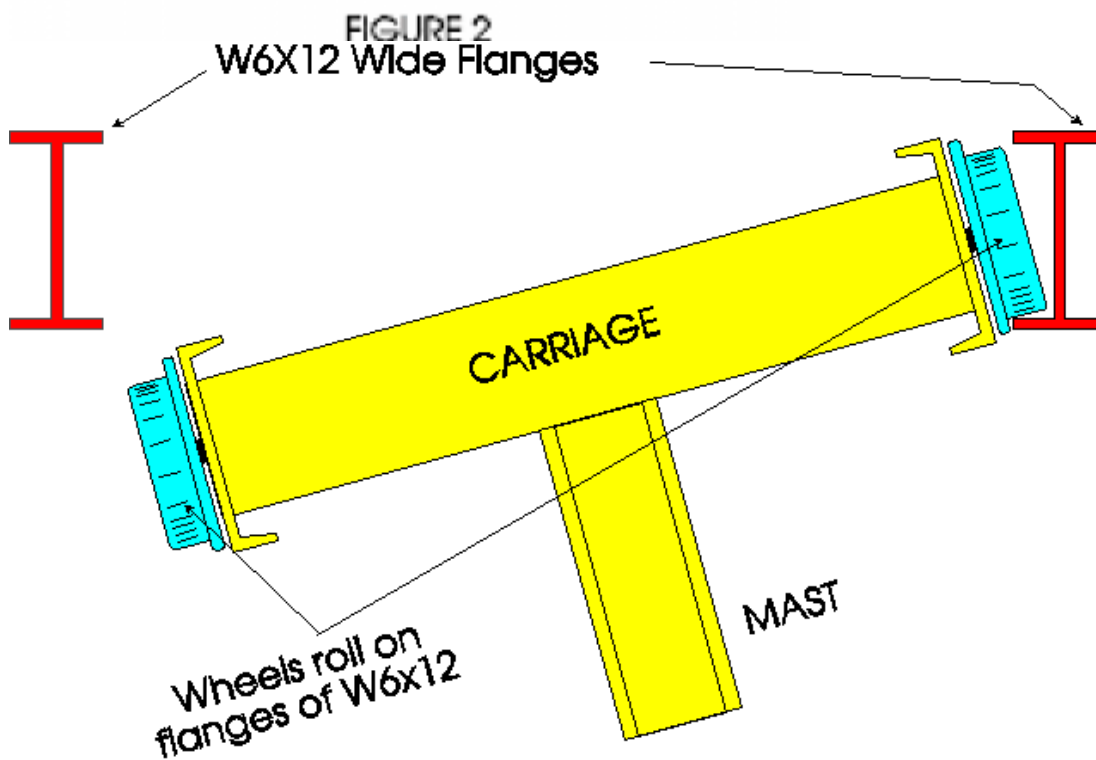
FIGURE 3

The accident caused the crane wheels on the back side of the pallet to be pulled free of the lower flange of the A588 steel W6X12 girder on the left side. (See Figures 2 and 3).

2. 10 am - I went to HH20E to investigate the accident. The crane trolley had slipped out from between the two crane girders and fell to the shop floor. The load was high above the floor and behind the south girder at time of failure. The evidence at the accident scene indicated that two trolley wheels had slipped off the south girder first. The weight of the load caused the trolley mast unit to pivot about the front girder. The mast swung up striking Mr. Michaels and throwing him about 20 feet north. Fortunately, he was thrown clear of the falling equipment. See also my notes on physical dimensions taken of crane unit, and photographs taken at the scene of the accident.

34. 8:00 am - JMS did engineering calculations showing the original design of the Lakewood Hi-stack system to be inadequate under the design loads. The major problem is the equivalent 813 pound lateral load on the W6x12 wide flange, which bends the section about its weak axis. The wide flange is overstressed by 3.29 to 1.

- Lakewood will proceed to repair the trolley unit.
- Lakewood will investigate installing safety lugs or beams on the trolley unit to prevent a similar accident in the future.
- Lakewood will check the need to reinforce or rework the bridge crane girders.
- Lakewood to verify if this system was a standard unit or a specially designed unit for Buchanan's needs. (Sue later found that this 8 foot 3 inch wide aisle unit was one of Lakewood's standard units.) Lakewood to inform us of the timing (schedule) and who will do the actual repair work. Buchanan to write a B94 account work order to accumulate our costs for possible back charging to Lakewood at a future date. Lakewood said they were no longer in this storage unit business and had sold the division to MBT Systems. They said it would take a few days to locate the original drawings for this system. We also agreed that

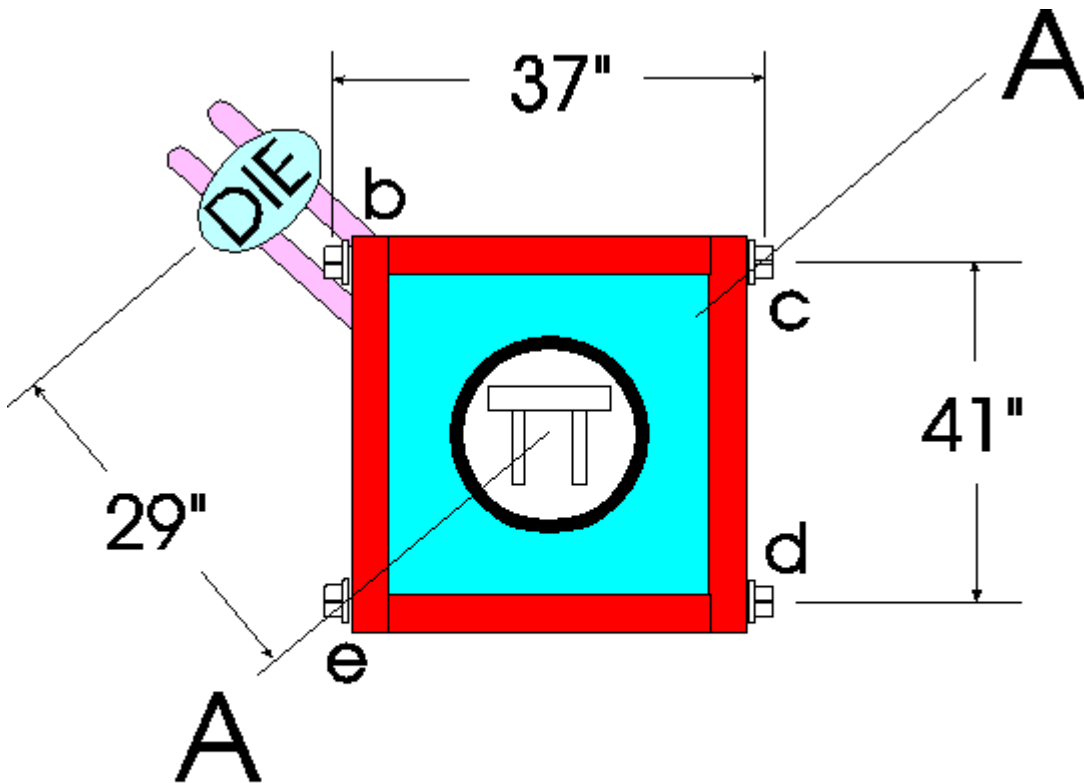
## Figure 8

The maximum loading on the W6x12 beam is realized when the pallet and die are rotated directly over one of the carriage wheels, as shown above.

The die and pallet live load rating is 2000 pounds, and can be up to 29 inches from the center of rotation of the crane. The dead load of the crane itself is 1875 pounds, and is located at the point of rotation of the crane. Using AISC-LRFD design procedures, the factored live load, including a 10% allowance for impact (Section A-4.1 and A-4.2) is

Moment about line A-A =  $3520\# * 29" = 102.080 \text{ in lbs}$ , which must be resisted by wheels b and d. Since these wheels are on the hypotenuse of a triangle, they are  $[(41/2)^2 + (37/2)^2]^{0.5} = 26.6 \text{ inches}$  from the center of the crane.

Assuming wheels b and d have the same load due to symmetry, Live load on wheel b = 1850#.

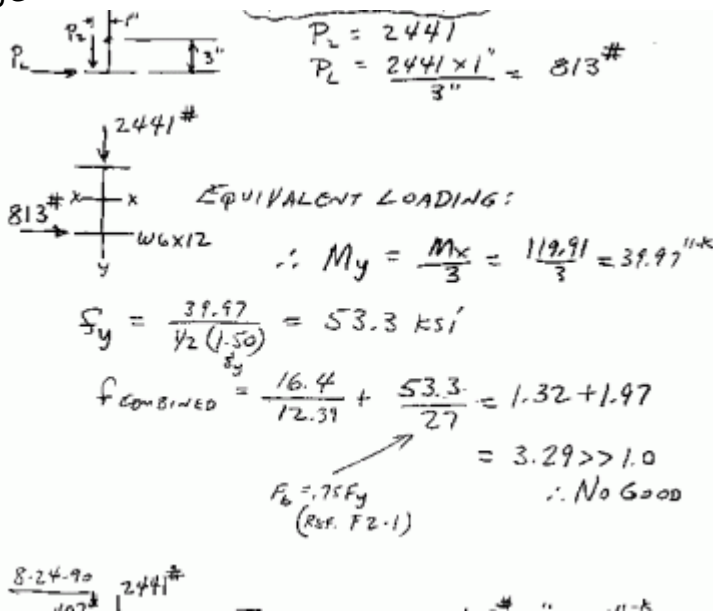
P2 is the maximum calculated wheel load, which is 1" off-center. PL is the equivalent lateral load which gives the same torsional twist to the beam as did P2, when P2 is moved to a direct shear position. This lateral load causes significant bending about the weak axis of the beam, as shown in the calculations below.
