The Case of the Lakewood "Hi-Stak"

Failure of a Stacking Hoist

On May 23rd, 1994, West Michaels, an employee of the Buchanan Company, a large construction vehicle manufacturer, had an accident and was seriously injured while operating a "Hi-Stak" crane. The crane had been purchased from the Lakewood Company, a large manufacturing firm, which had designed, manufactured, and sold hundreds self-contained storage/retrieval systems.

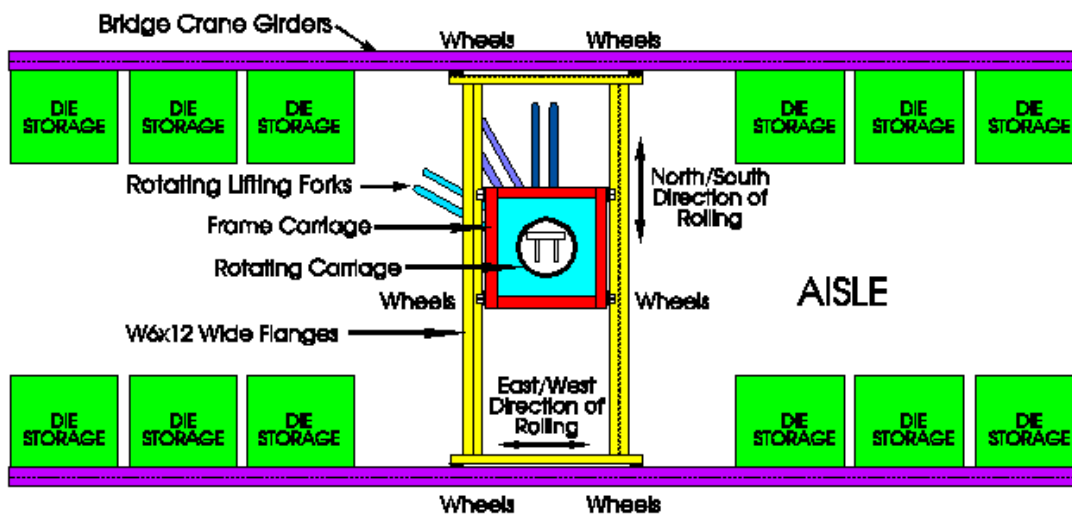
Figure 1

The Lakewood Company, a fairly large manufacturing firm, has designed, manufactured and sold hundreds of self-contained storage/retrieval systems which are used for storing heavy parts such as dies, which must intermittently be taken from storage and used elsewhere in the plant. The system consists of two large sets of storage racks, facing each other, with an integral crane that runs between them on 2 bridge crane girders on the top back edges of the storage racks (see Figure 1).
