The Case of the Lakewood "Hi-Stak"

Failure of a Stacking Hoist

Subject: ACCIDENT INVESTIGATION - Building HH:20E

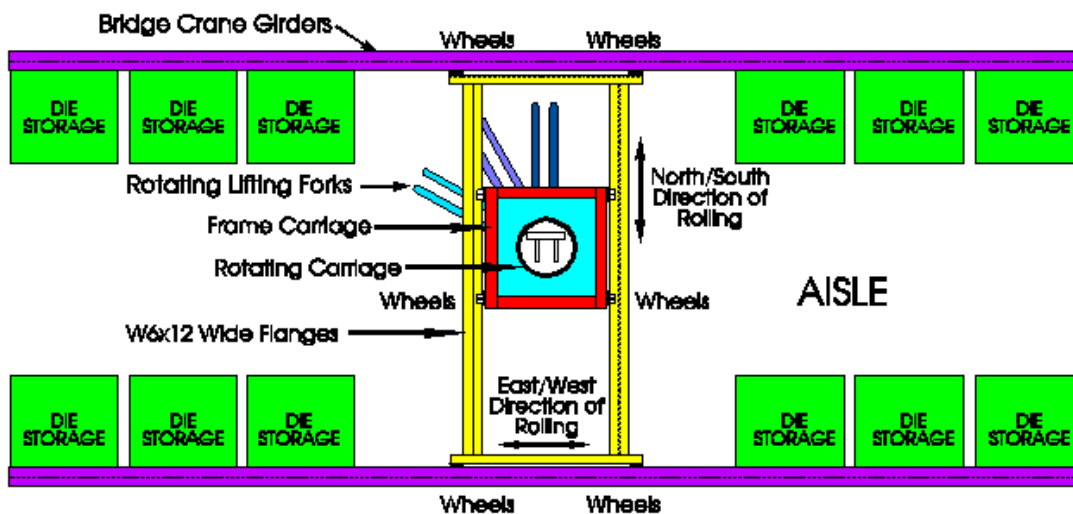
Figure 1

The Lakewood Company, a fairly large manufacturing firm, has designed, manufactured and sold hundreds of self-contained storage/retrieval systems which are used for storing heavy parts such as dies, which must intermittently be taken from storage and used elsewhere in the plant. The system consists of two large sets of storage racks, facing each other, with an integral crane that runs between them on 2 bridge crane girders on the top back edges of the storage racks (see Figure 1).

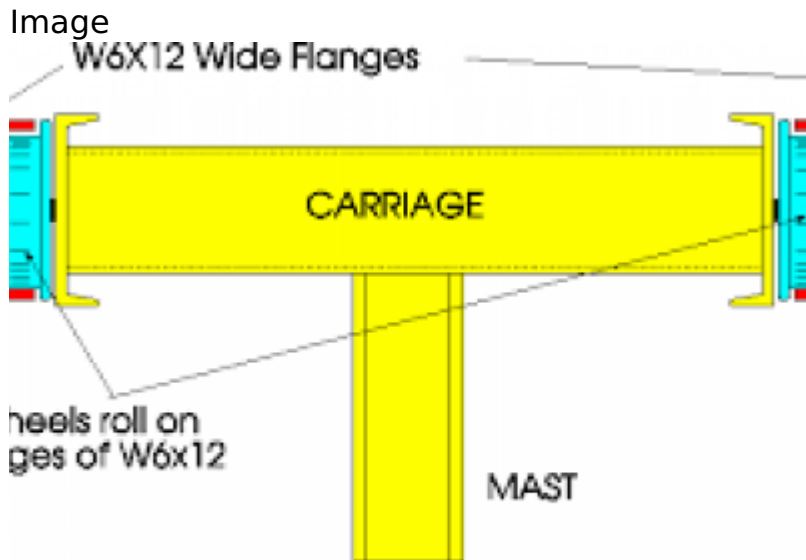
FIGURE 3

The accident caused the crane wheels on the back side of the pallet to be pulled free of the lower flange of the A588 steel W6X12 girder on the left side. (See Figures 2 and 3).

2. 10 am - I went to HH20E to investigate the accident. The crane trolley had slipped out from between the two crane girders and fell to the shop floor. The load was high above the floor and behind the south girder at time of failure. The evidence at the accident scene indicated that two trolley wheels had slipped off the south girder first. The weight of the load caused the trolley mast unit to pivot about the front girder. The mast swung up striking Mr. Michaels and throwing him about 20 feet north. Fortunately, he was thrown clear of the falling equipment. See also my notes on physical dimensions taken of crane unit, and photographs taken at the scene of the accident.

The employee was doing his job using the tools and procedures provided to him by Buchanan. Buchanan had purchased the unit as a self-contained system from Lakewood, Inc. through their representative Fogerty Brothers Company. The 2 bridge crane girders were obviously too weak to keep the trolley unit in its proper position during normal loading. Our structural calculations, based on the known live and dead loads without adding impact, show that the one girder was overloaded. The girder was not stable under load and deflected laterally enough to allow the trolley wheels to slip off the girder flange. The crane girders must be reinforced for vertical load. The lateral loading caused by the trolley wheel position on the crane girder bottom flange should be reduced or the girder must also be reinforced for lateral stability. Safety lugs mounted on the trolley unit and over the crane girders should also be installed. Lakewood will design the changes and obtain our

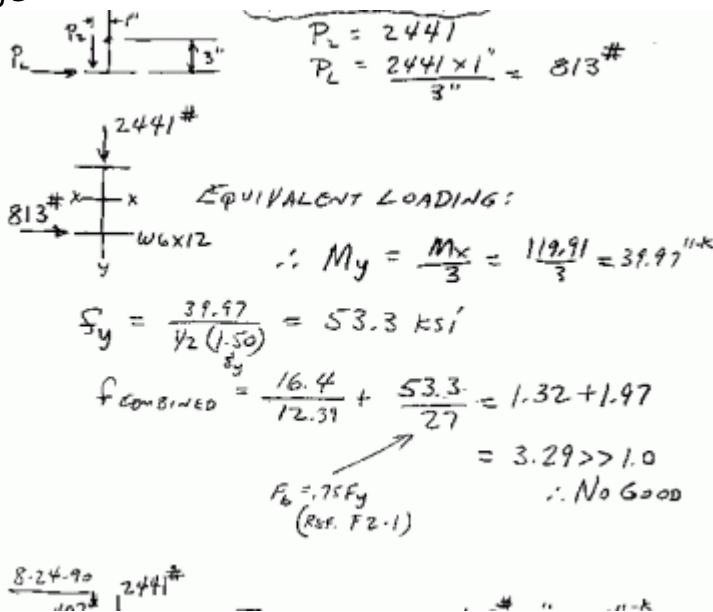
34. 8:00 am - JMS did engineering calculations showing the original design of the Lakewood Hi-stack system to be inadequate under the design loads. The major problem is the equivalent 813 pound lateral load on the W6x12 wide flange, which bends the section about its weak axis. The wide flange is overstressed by 3.29 to 1.

P2 is the maximum calculated wheel load, which is 1" off-center. PL is the equivalent lateral load which gives the same torsional twist to the beam as did P2, when P2 is moved to a direct shear position. This lateral load causes significant bending about the weak axis of the beam, as shown in the calculations below.
