Online Ethics Center
FOR ENGINEERING AND SCIENCE

The Space Shuttle Challenger Disaster

A case study looking at the explosion of the Challenger Space Shuttle.

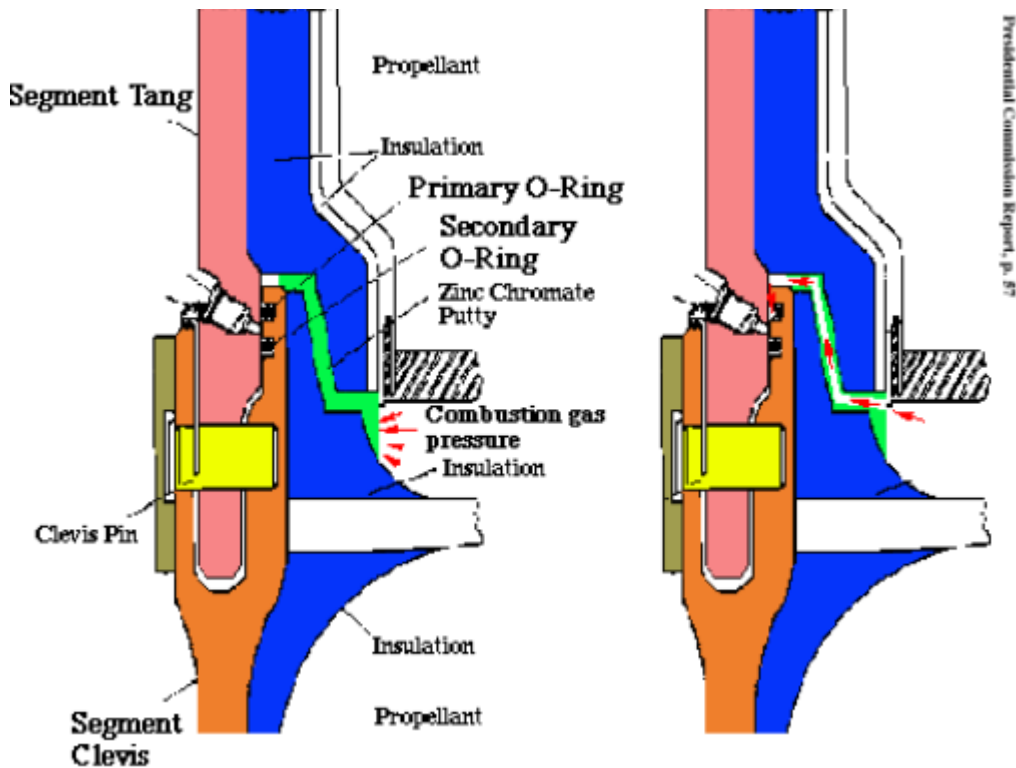
There is an SRB attached to each side of the external fuel tank. Each booster is 149 feet long and 12 feet in diameter. Before ignition, each booster weighs 2 million pounds. Solid rockets in general produce much more thrust per pound than their liquid fuel counterparts. The drawback is that once the solid rocket fuel has been ignited, it cannot be turned off or even controlled. So it was extremely important that the shuttle SRBs were properly designed. Morton Thiokol was awarded the contract to design and build the SRBs in 1974. Thiokol's design is a scaled-up version of a Titan missile which had been used successfully for years. NASA accepted the design in 1976. The booster is comprised of seven hollow metal cylinders. The solid rocket fuel is cast into the cylinders at the Thiokol plant in Utah, and the cylinders are assembled into pairs for transport to Kennedy Space Center in Florida. At KSC, the four booster segments are assembled into a completed booster rocket. The joints where the segments are joined together at KSC are known as field joints (See Figure 1).

These field joints consist of a tang and clevis joint. The tang and clevis are held together by 177 clevis pins. Each joint is sealed by two O rings, the bottom ring known as the primary O ring, and the top known as the secondary O-ring. (The Titan booster had only one O-ring. The second ring was added as a measure of redundancy since the boosters would be lifting humans into orbit. Except for the increased scale of the rocket's diameter, this was the only major difference between the shuttle booster and the Titan booster.) The purpose of the O-rings is to prevent hot combustion gasses from escaping from the inside of the motor. To provide a barrier between the rubber O-rings and the combustion gasses, a heat resistant putty is applied to the inner section of the joint prior to assembly. The gap between the tang and the clevis determines the amount of compression on the O-ring. To minimize the gap and increase the squeeze on the O-ring, shims are inserted between the tang and the outside leg of the clevis.

The air pressure forces the O-ring into the gap between the tang and clevis. Pressure loads are also applied to the walls of the cylinder, causing the cylinder to balloon slightly. This ballooning of the cylinder walls caused the gap between the tang and clevis gap to open. This effect has come to be known as joint rotation. Morton-Thiokol discovered this joint rotation as part of its testing program in 1977. Thiokol discussed the problem with NASA and started analyzing and testing to determine

The primary O-ring was too cold to seat properly, the cold-stiffened heat resistant putty that protected the rubber O-rings from the fuel collapsed, and gases at over 5000°F burned past both O-rings across seventy degrees of arc. Eight hundredths of a second after ignition, the shuttle lifted off. Engineering cameras focused on the right-hand booster showed about nine smoke puffs coming from the booster aft field joint. Before the shuttle cleared the tower, oxides from the burnt propellant temporarily sealed the field joint before flames could escape. Fifty-nine seconds into the flight, Challenger experienced the most violent wind shear ever encountered on a shuttle mission. The glassy oxides that sealed the field joint were shattered by the stresses of the wind shear, and within seconds flames from the field joint burned through the external fuel tank. Hundreds of tons of propellant ignited, tearing apart the shuttle. One hundred seconds into the flight, the last bit of telemetry data was transmitted from the Challenger.

1. Dimensional tolerances of the metal joint were tightened.
2. The O-ring diameter was increased, and its dimensional tolerances were tightened.
3. The use of the shims mentioned above was introduced. Further testing by Thiokol revealed that the second seal, in some cases, might not seal at all. Additional changes in the shim thickness and O-ring diameter were made to correct the problem.
