Case 1: Fire by Sodium Coolant Leak at Prototype Fast Breeder Reactor, Monju

Hiroshi Iino

Case 1 of Teaching Case Studies of Accidents in Nuclear Energy Development in Japan describes a fire caused by a massive sodium coolant leak at the Monju fast breeder reactor.

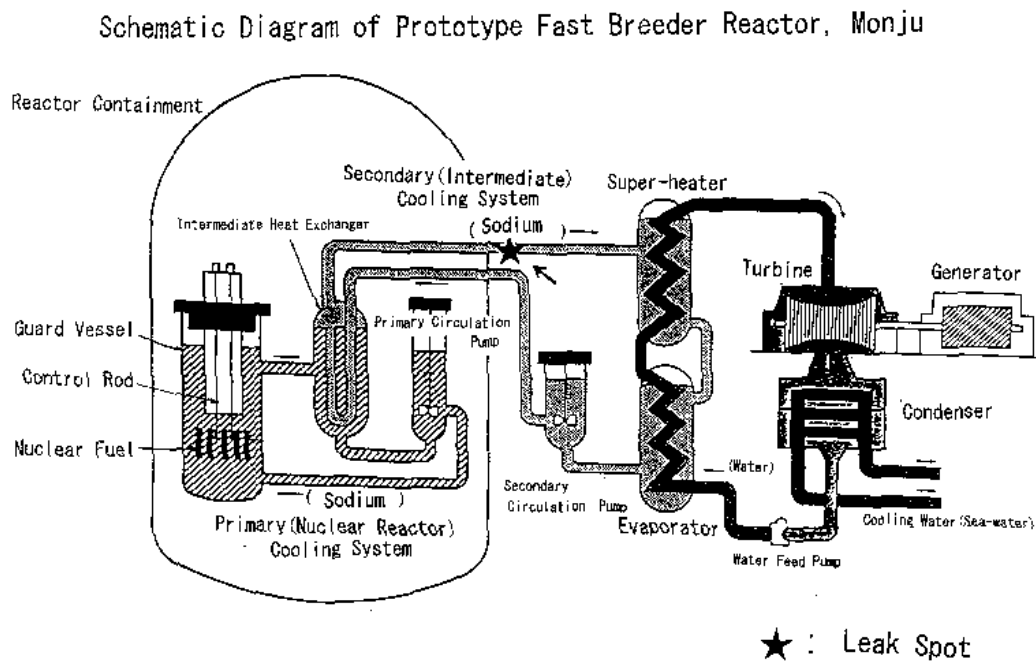
Figure 1:

On December 8, 1995, a prototype fast breeder reactor, Monju, located in Tsuruga City, 350km west of Tokyo, was operating at 40% power. Refer to JNC's detailed technical explanation in English of Monju and the accident at <http://www.jnc.go.jp/zmonju/mjweb/index.htm>. The Power Reactor and Nuclear Fuel Development Corp (PNC), a government controlled organization, operated this reactor. At 19:47 high temperature liquid sodium coolant at one of the three secondary heat exchangers started leaking through a broken thermometer sheath (designed by IH Company, OD: 10mm, ID: 4mm, Length: 150mm) on the piping and it ignited on contact with air. As shown in Fig. 1, the primary heat exchangers are

designed to take heat out of the core of the reactor to the secondary heat exchangers, which then transfer the heat to steam generators for power. Because of this design, it was a simple fire caused by the leakage of chemically reactive but non-radioactive sodium coolant. But due to the delay in shutting down of the reactor, 640kg of the sodium leaked in 3 hours and caused some unexpected damage by the fire and chemical reactions to the surrounding structure.
