# Case 1: Fire by Sodium Coolant Leak at Prototype Fast Breeder Reactor, Monju

Hiroshi Iino

Case 1 of Teaching Case Studies of Accidents in Nuclear Energy Development in Japan describes a fire caused by a massive sodium coolant leak at the Monju fast breeder reactor.

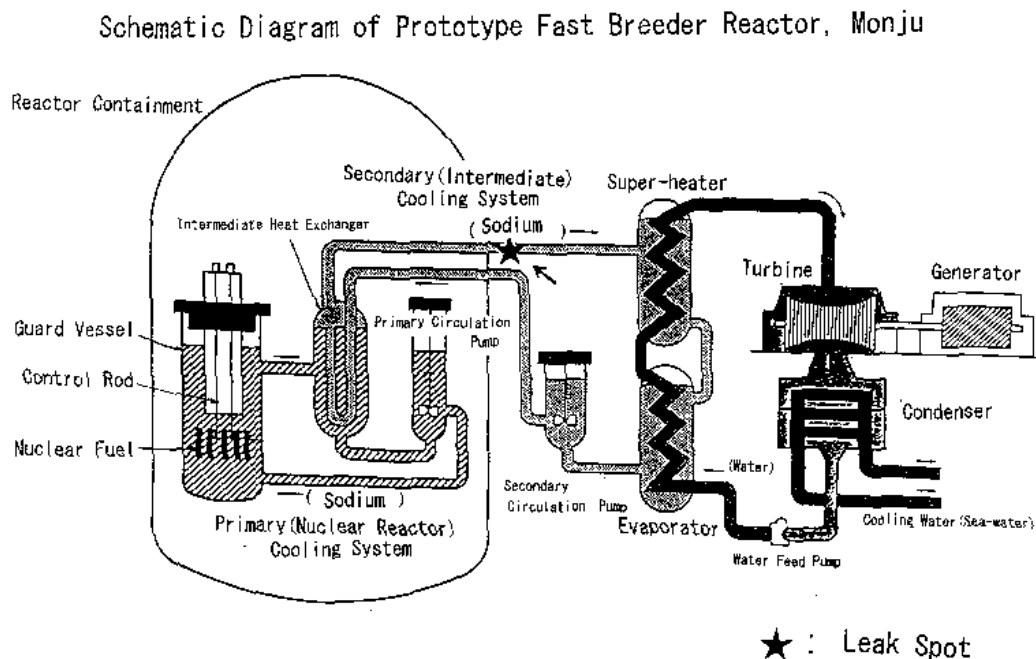
**Figure 1:**

On December 8, 1995, a prototype fast breeder reactor, Monju, located in Tsuruga City, 350km west of Tokyo, was operating at 40% power. Refer to JNC's detailed technical explanation in English of Monju and the accident at <http://www.jnc.go.jp/zmonju/mjweb/index.htm>. The Power Reactor and Nuclear Fuel Development Corp (PNC), a government controlled organization, operated this reactor. At 19:47 high temperature liquid sodium coolant at one of the three secondary heat exchangers started leaking through a broken thermometer sheath (designed by IH Company, OD: 10mm, ID: 4mm, Length: 150mm) on the piping and it ignited on contact with air. As shown in Fig. 1, the primary heat exchangers are

designed to take heat out of the core of the reactor to the secondary heat exchangers, which then transfer the heat to steam generators for power. Because of this design, it was a simple fire caused by the leakage of chemically reactive but non-radioactive sodium coolant. But due to the delay in shutting down of the reactor, 640kg of the sodium leaked in 3 hours and caused some unexpected damage by the fire and chemical reactions to the surrounding structure.

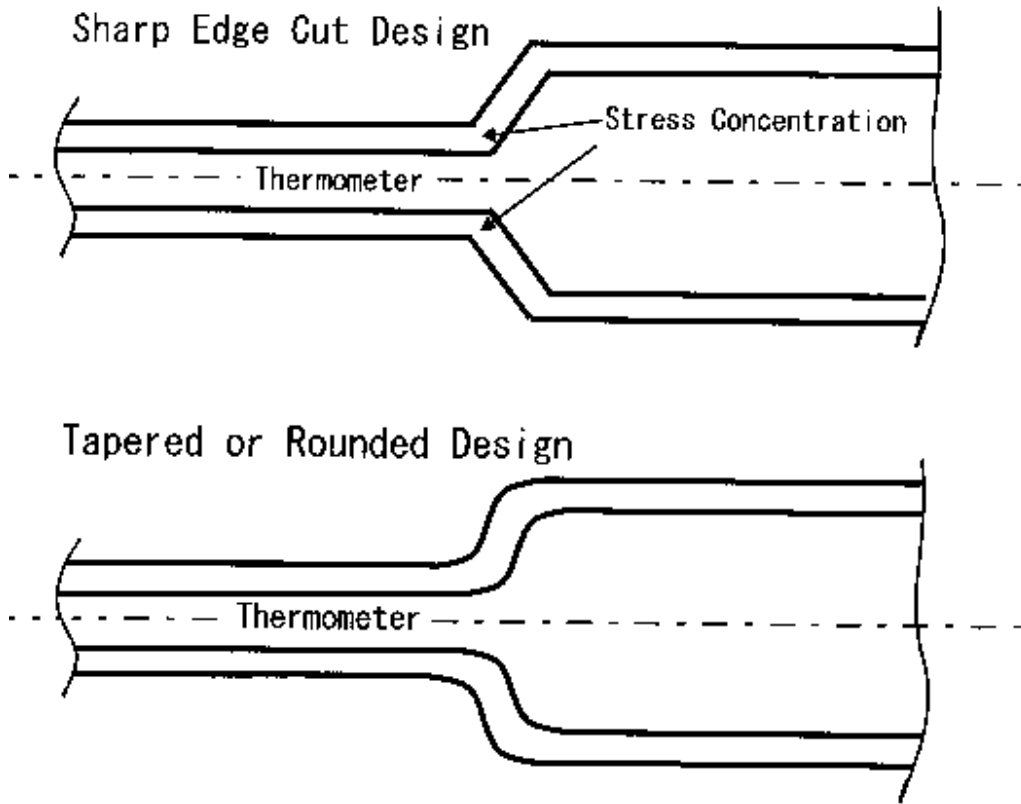
**Figure 2:**

The sheath was found to have been broken by following design errors such as,

1. The sharp cut edge design of the sheath as shown in Fig. 2, which caused stress concentration and breakage,
  2. Neglect of newly established mechanical design analysis of vibration of the sheath parallel to the sodium flow and
  3. The IH company's failure to consider the fact that liquid sodium is 120 times more heat conductive than water and to use the another contractor's (the H company's) better and simpler design for those of the primary heat exchangers.
- See [Fig. 3](#).
