Case 1: Fire by Sodium Coolant Leak at Prototype Fast Breeder Reactor, Monju

Case 1 of Teaching Case Studies of Accidents in Nuclear Energy Development in Japan describes a fire caused by a massive sodium coolant leak at the Monju fast breeder reactor.

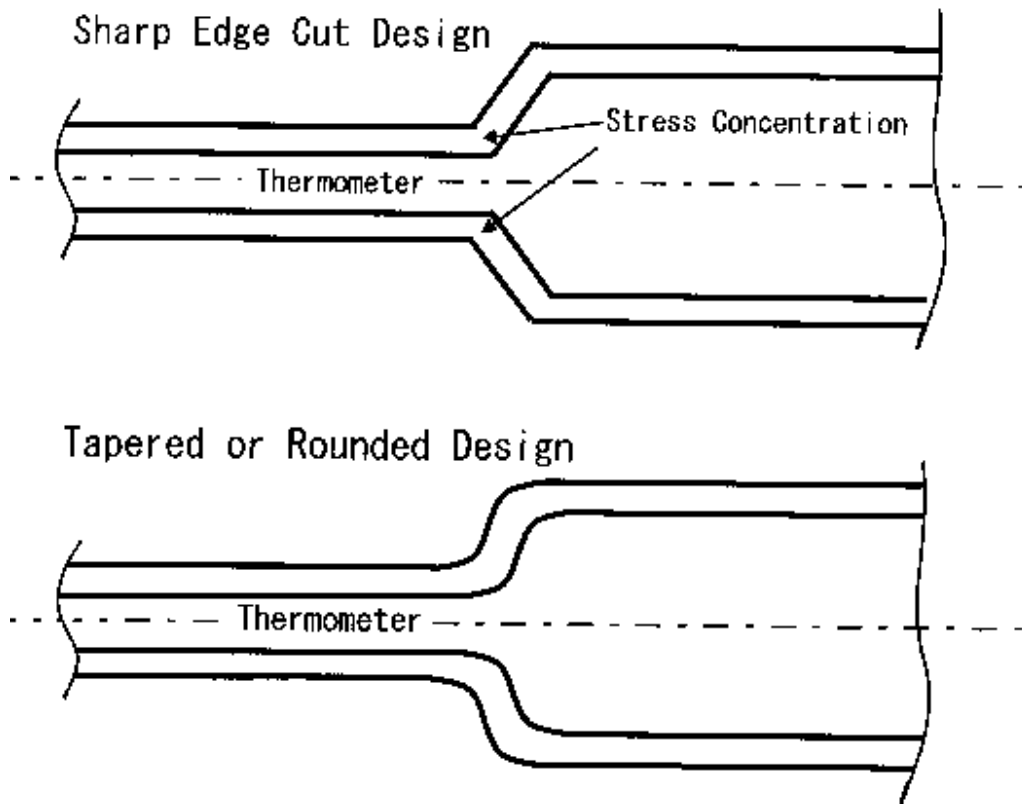
Figure 2:

The sheath was found to have been broken by following design errors such as,

1. The sharp cut edge design of the sheath as shown in Fig. 2, which caused stress concentration and breakage,
 2. Neglect of newly established mechanical design analysis of vibration of the sheath parallel to the sodium flow and
 3. The IH company's failure to consider the fact that liquid sodium is 120 times more heat conductive than water and to use the another contractor's (the H company's) better and simpler design for those of the primary heat exchangers.
- See [Fig. 3](#).

Design of Broken Thermometer Sheath (Cross Section)
