Case 1: Fire by Sodium Coolant Leak at Prototype Fast Breeder Reactor, Monju

Case 1 of Teaching Case Studies of Accidents in Nuclear Energy Development in Japan describes a fire caused by a massive sodium coolant leak at the Monju fast breeder reactor.

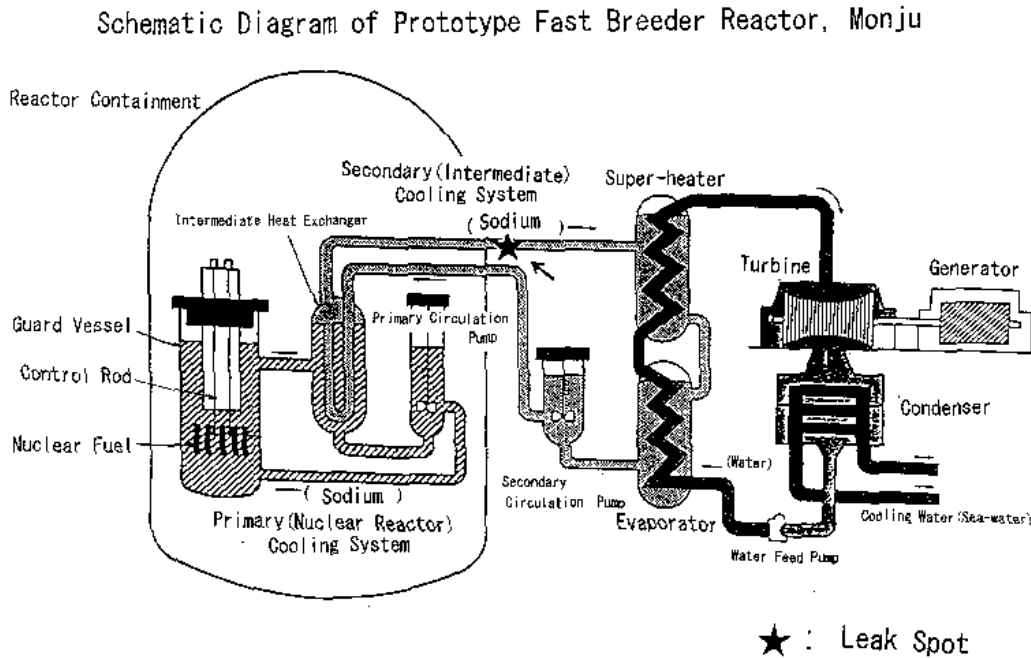
Figure 1:

Because of this design, it was a simple fire caused by the leakage of chemically reactive but non-radioactive sodium coolant. But due to the delay in shutting down of the reactor, 640kg of the sodium leaked in 3 hours and caused some unexpected damage by the fire and chemical reactions to the surrounding structure.
