Case 1: Fire by Sodium Coolant Leak at Prototype Fast Breeder Reactor, Monju

Hiroshi Iino

Case 1 of Teaching Case Studies of Accidents in Nuclear Energy Development in Japan describes a fire caused by a massive sodium coolant leak at the Monju fast breeder reactor.

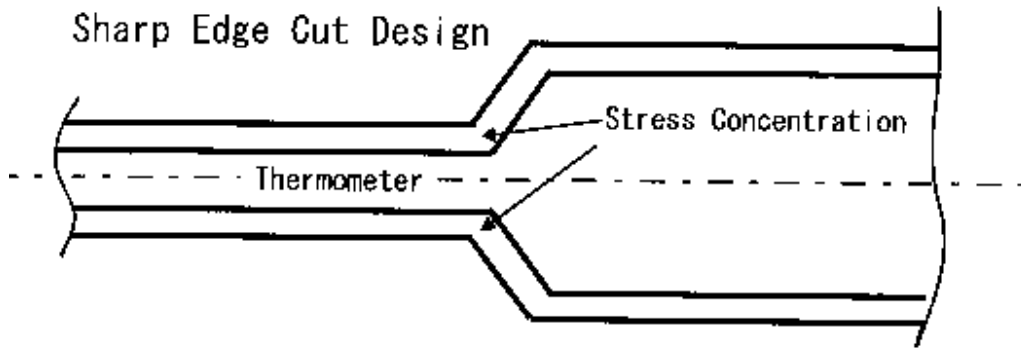
Sharp Edge Cut Design

The sheath was found to have been broken by following design errors such as,

1. The sharp cut edge design of the sheath as shown in Fig. 2, which caused stress concentration and breakage,
 2. Neglect of newly established mechanical design analysis of vibration of the sheath parallel to the sodium flow and
 3. The IH company's failure to consider the fact that liquid sodium is 120 times more heat conductive than water and to use the another contractor's (the H company's) better and simpler design for those of the primary heat exchangers.
- See [Fig. 3](#).

Design of Broken Thermometer Sheath (Cross Section)

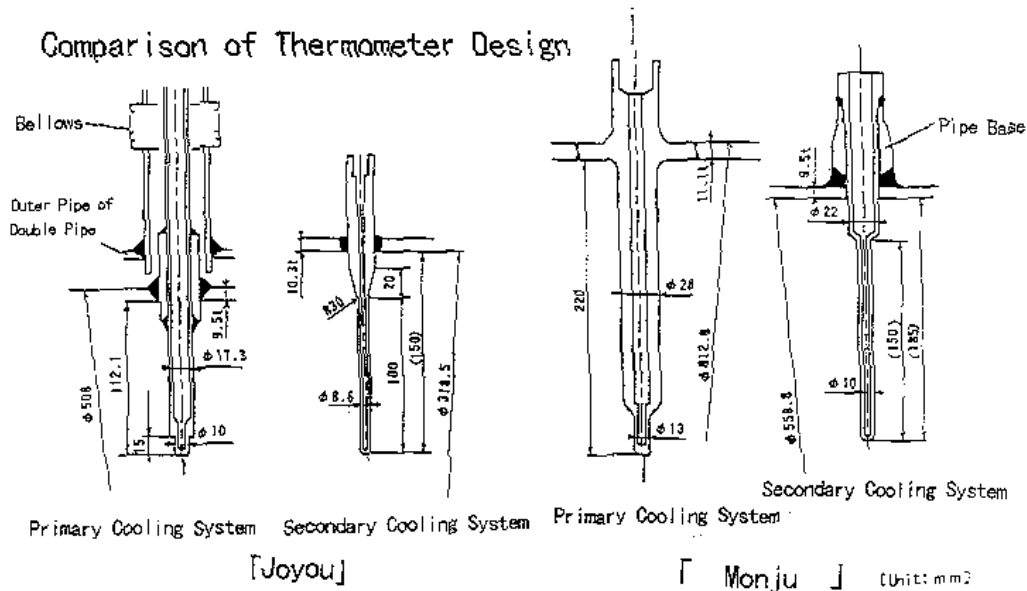
Figure 3:

Comparison of Thermometer Design
