Case 1: Fire by Sodium Coolant Leak at Prototype Fast Breeder Reactor, Monju

Hiroshi Iino

Case 1 of Teaching Case Studies of Accidents in Nuclear Energy Development in Japan describes a fire caused by a massive sodium coolant leak at the Monju fast breeder reactor.

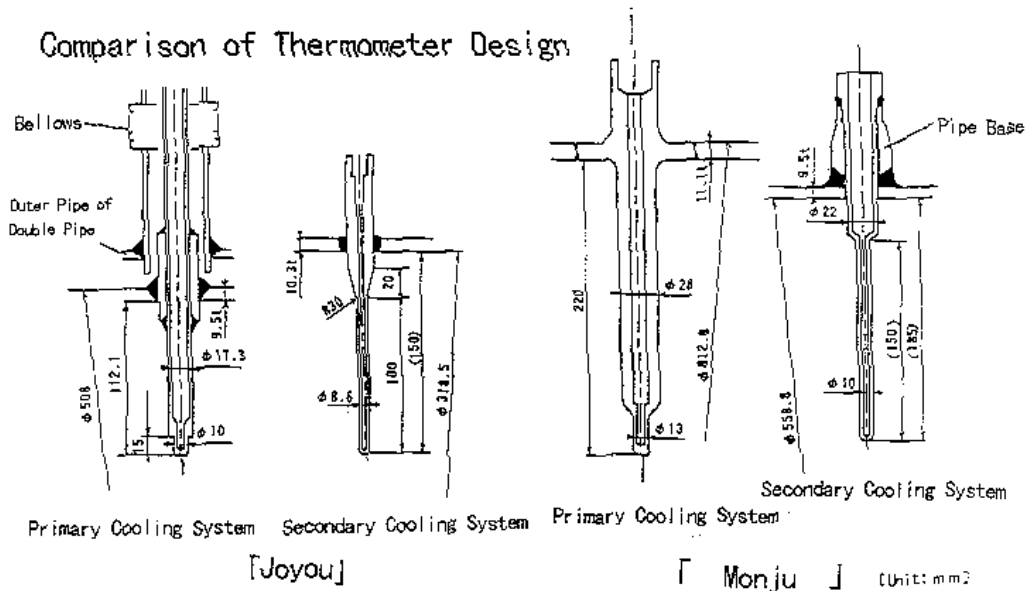
Figure 3:

Comparison of Thermometer Design

1. The sharp cut edge design of the sheath as shown in Fig. 2, which caused stress concentration and breakage,
 2. Neglect of newly established mechanical design analysis of vibration of the sheath parallel to the sodium flow and
 3. The IH company's failure to consider the fact that liquid sodium is 120 times more heat conductive than water and to use the another contractor's (the H company's) better and simpler design for those of the primary heat exchangers.
- See [Fig. 3](#).
