Case 2: Fire and Explosion at Bituminization Demonstration Facility in 1997

Case 2 of Teaching Case Studies of Accidents in Nuclear Energy Development in Japan describes an explosion at Tokai Works of PNC, located in Tokaimura, 140km north of Tokyo.

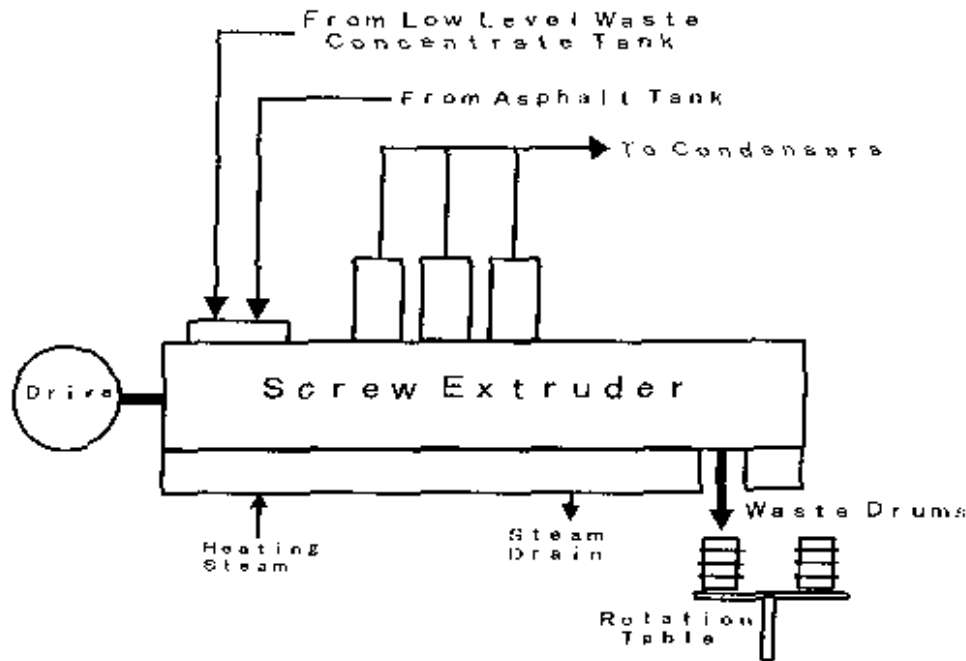
Figure 4:

Asphalt Process for Treating Low Level Nuclear Waste
