# Case 2: Fire and Explosion at Bituminization Demonstration Facility in 1997

Case 2 of Teaching Case Studies of Accidents in Nuclear Energy Development in Japan describes an explosion at Tokai Works of PNC, located in Tokaimura, 140km north of Tokyo.

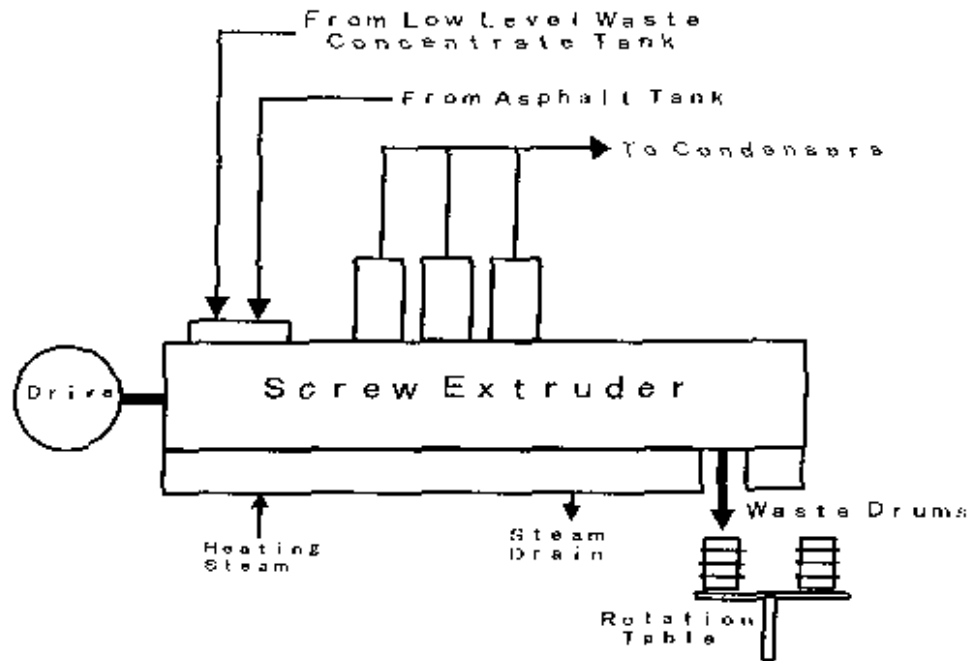
**Figure 4:**

### Asphalt Process for Treating Low Level Nuclear Waste

Engineers planned an experiment to reduce a flow rate by 10% then 20%. Operators from subcontractors observed lowering viscosity of the final mixture, an indication of higher temperature but the thermometer at the exit of the extruder was not working

well for years. When they saw pillars of flame on the drums being cooled down, they splashed water from sprinklers for one minute just enough to extinguish the fire. They reported to the engineers. No engineer responsible to the operation came to the place before an explosion occurred 10 hours later and a small amount of radioactive materials went out of the building. Several tens of workers had been scheduled to enter the building 40 minutes after the explosion. It was very fortunate that there were no casualties. I think ordinary engineers could have foreseen the explosion if they had understood what caused the original fire and time necessary to cool down the oxidation reaction in the 180 liter drums. This case can be used to caution the students against the following mistakes:
