Case 2: Fire and Explosion at Bituminization Demonstration Facility in 1997

Hiroshi Iino

Case 2 of Teaching Case Studies of Accidents in Nuclear Energy Development in Japan describes an explosion at Tokai Works of PNC, located in Tokaimura, 140km north of Tokyo.

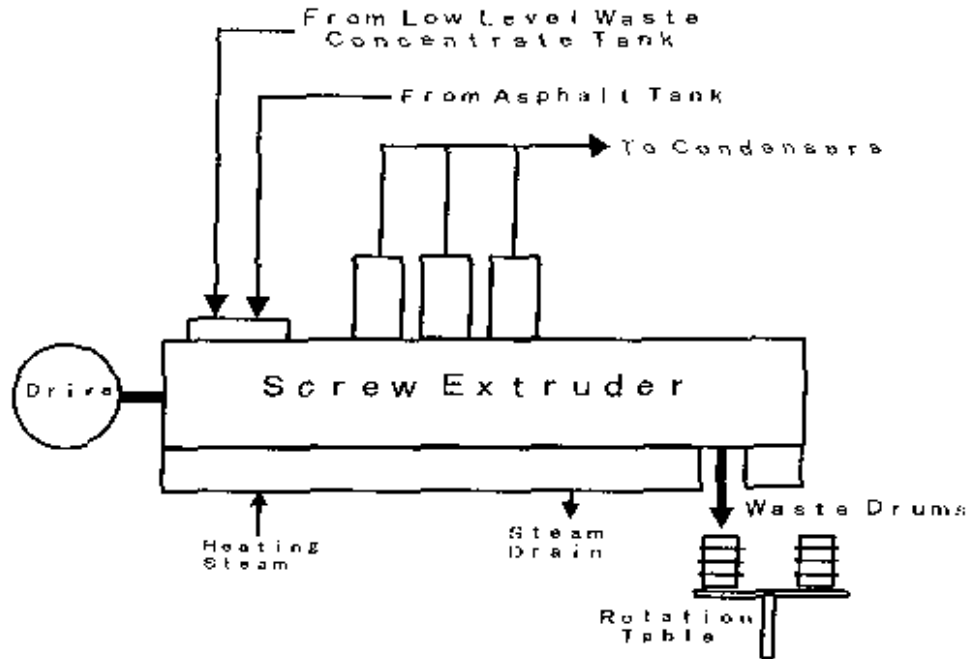
Figure 4:

Asphalt Process for Treating Low Level Nuclear Waste
