## **Case 2: Fire and Explosion at Bituminization Demonstration Facility in 1997**

Hiroshi Iino

Case 2 of Teaching Case Studies of Accidents in Nuclear Energy Development in Japan describes an explosion at Tokai Works of PNC, located in Tokaimura, 140km north of Tokyo.

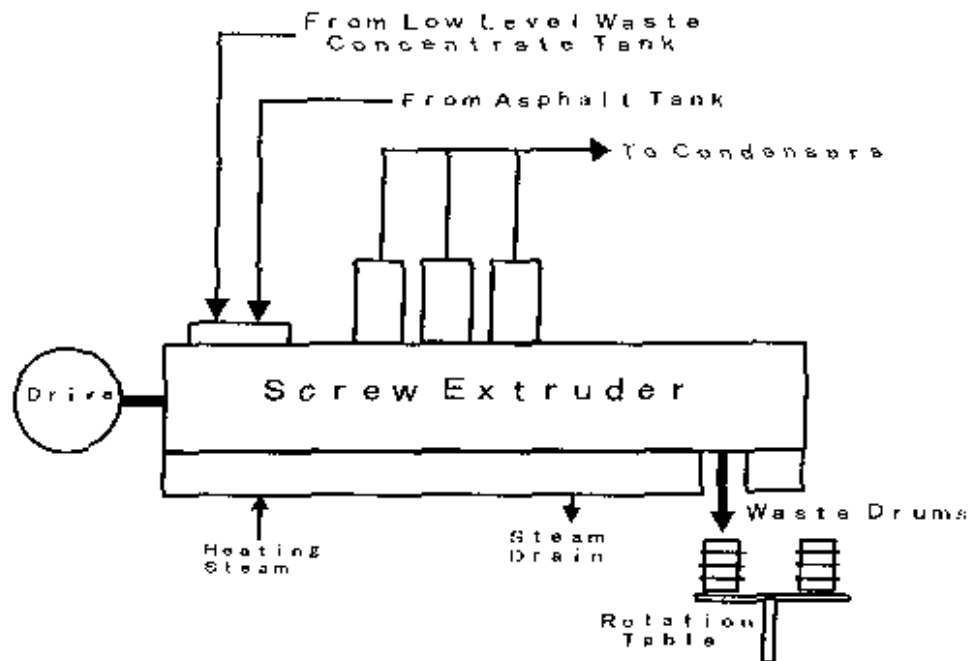
**Figure 4:**

## Asphalt Process for Treating Low Level Nuclear Waste
