# The Case of the Lakewood "Hi-Stak"

Failure of a Stacking Hoist

1995

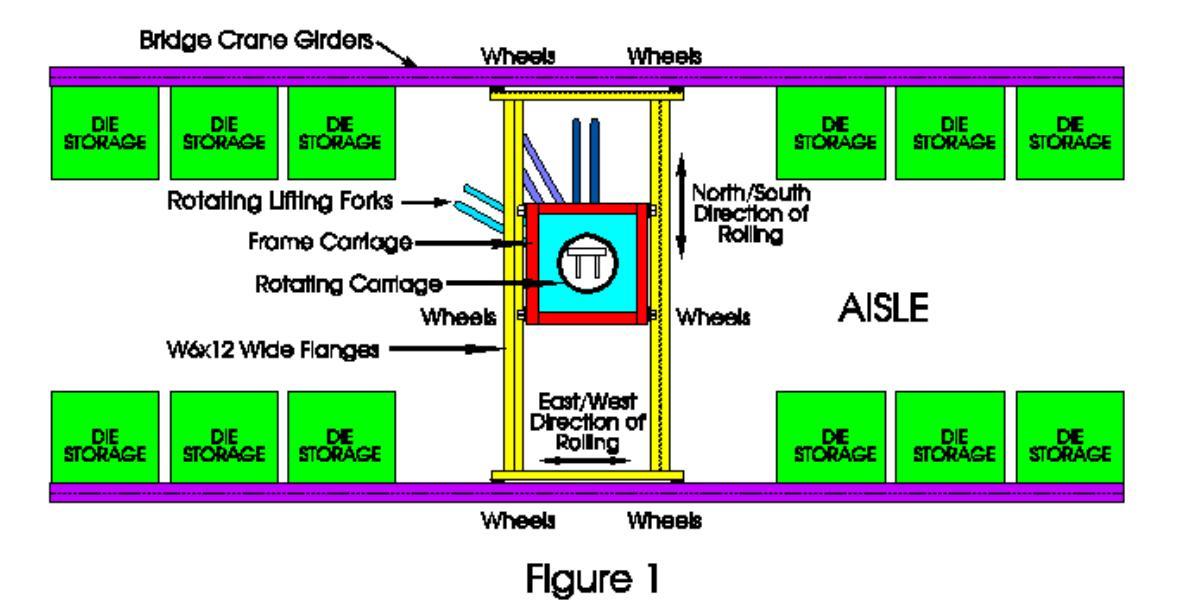
The Lakewood Company, a fairly large manufacturing firm, has designed, manufactured and sold hundreds of self-contained storage/retrieval systems which are used for storing heavy parts such as dies, which must intermittently be taken from storage and used elsewhere in the plant. The system consists of two large sets of storage racks, facing each other, with an integral crane that runs between them on 2 bridge crane girders on the top back edges of the storage racks (see Figure 1).

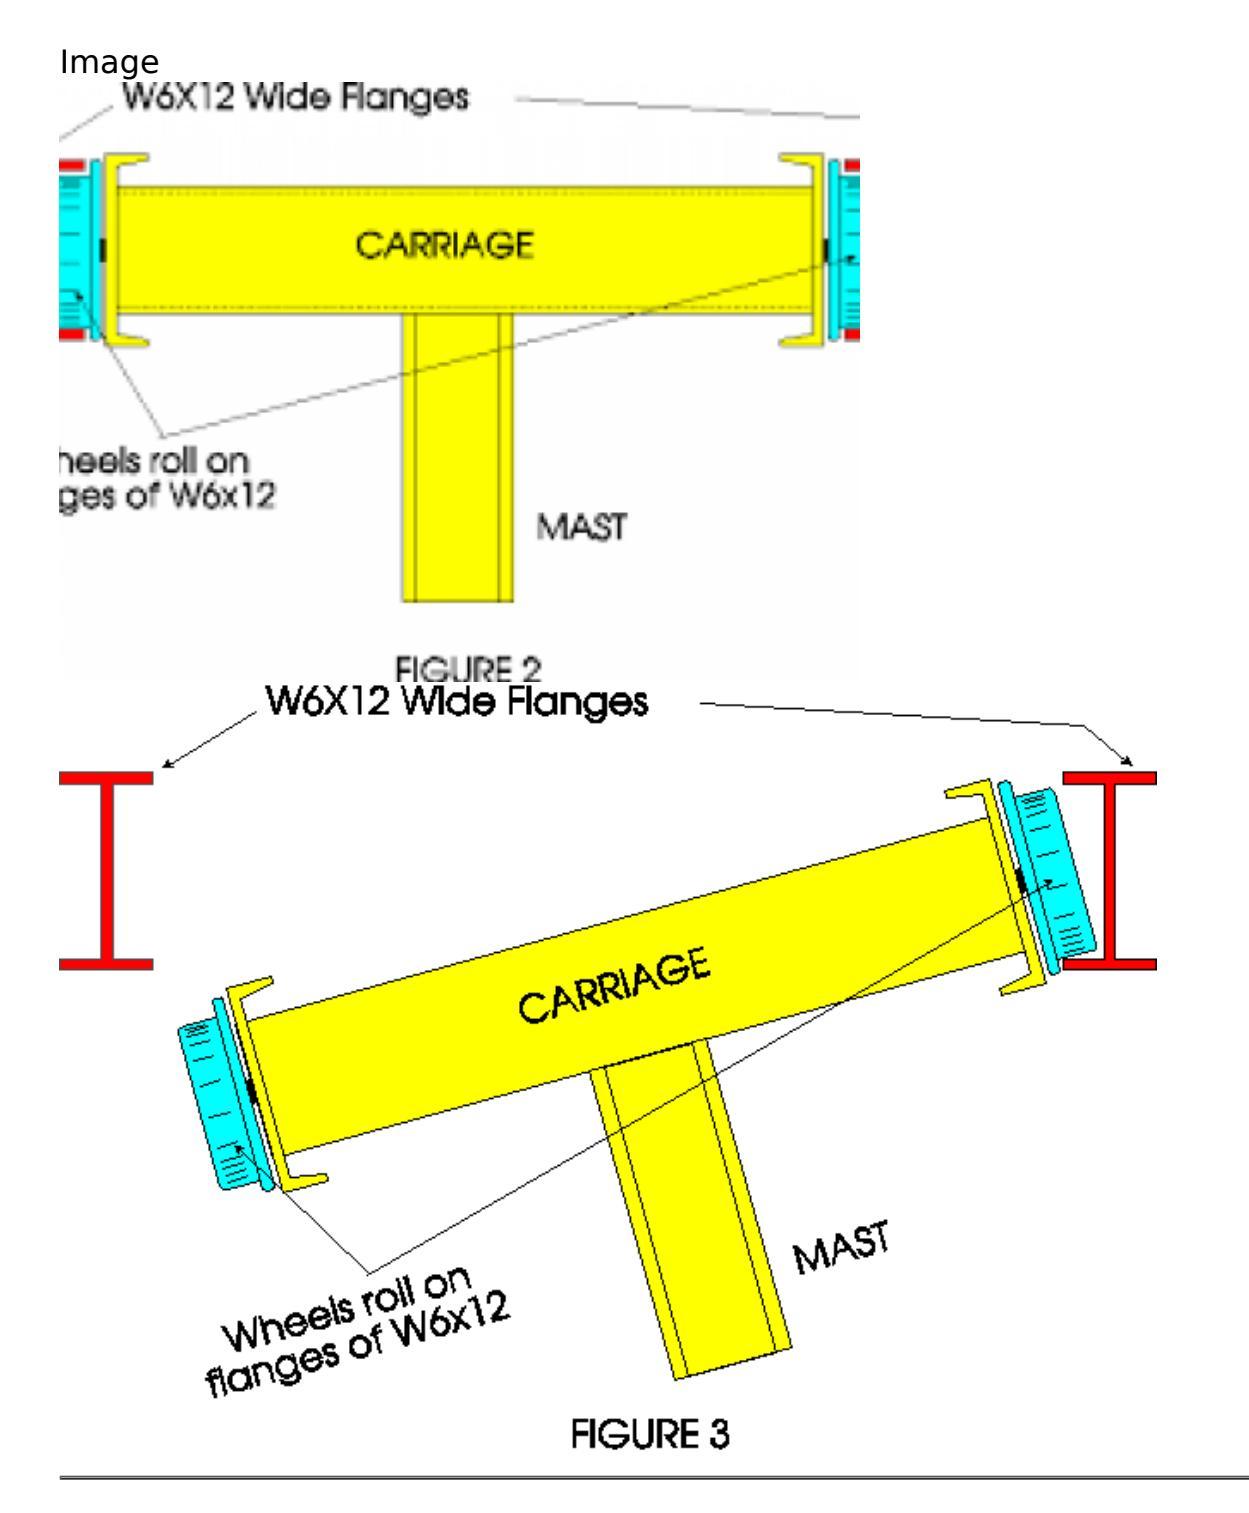
According to eye witnesses, West had retrieved a 1,460 pound die from the top shelf, and was pulling it to the end of the aisle. The load was well within the crane's advertised limit of 2,000 pounds. The next thing West knew, as stated in the accident report, he was thrown about 20 feet. His next recollection was awakening in the hospital bed. The accident caused the crane wheels on the back side of the pallet to be pulled free of the lower flange of the A588 steel W6X12 girder on the left side. (See Figures 2 and 3).

2. 10 am - I went to HH20E to investigate the accident. The crane trolley had slipped out from between the two crane girders and fell to the shop floor. The load was high above the floor and behind the south girder at time of failure. The evidence at the accident scene indicated that two trolley wheels had slipped off the south girder first. The weight of the load caused the trolley mast unit to pivot about the front girder. The mast swung up striking Mr. Michaels and throwing him about 20 feet north. Fortunately, he was thrown clear of the falling equipment. See also my notes on physical dimensions taken of crane unit, and photographs taken at the scene of the accident.

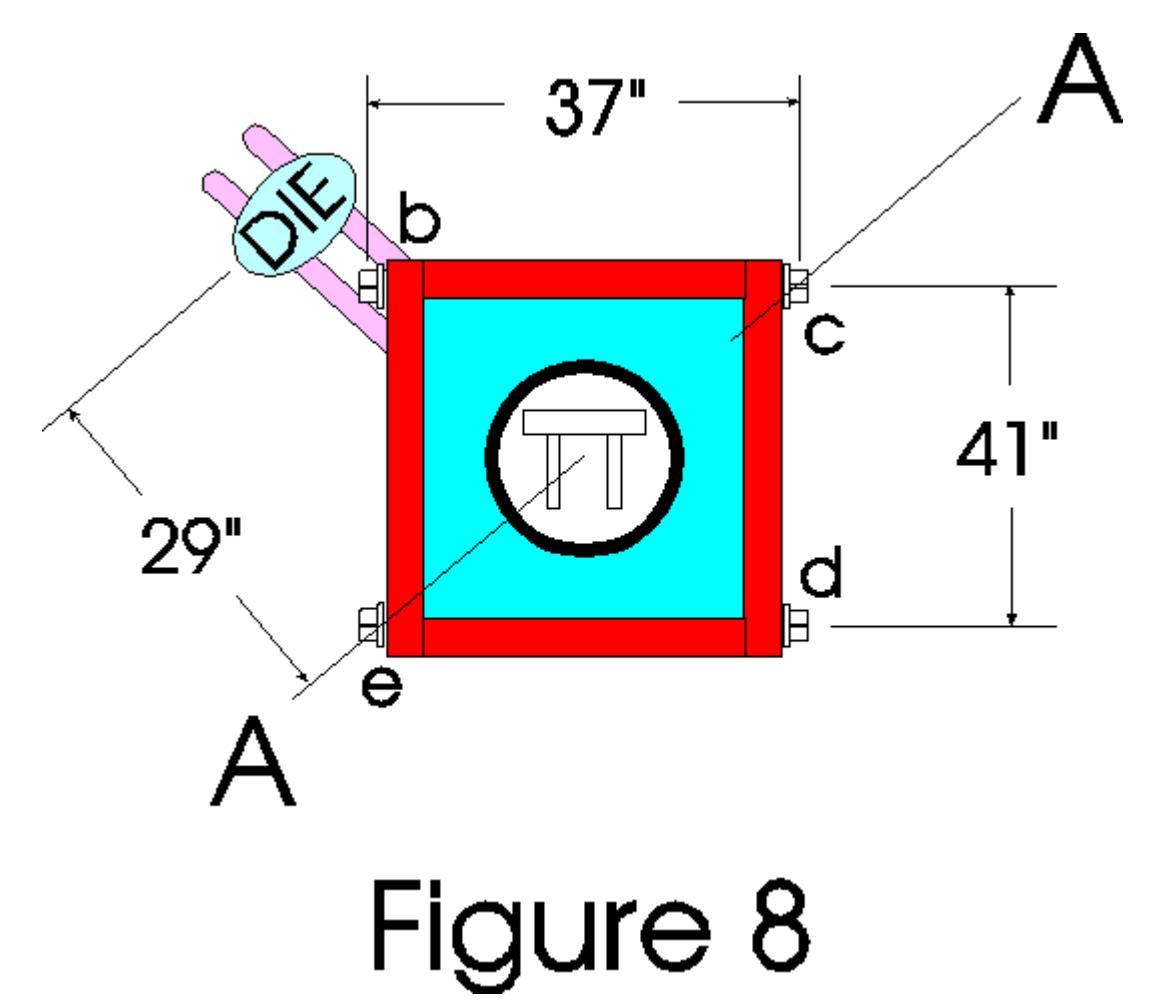
#### Buchanan Calculations Showing Beam To Be Poorly Designed

34. 8:00 am - JMS did engineering calculations showing the original design of the Lakewood Hi-stack system to be inadequate under the design loads. The major problem is the equivalent 813 pound lateral load on the W6x12 wide flange, which bends the section about its weak axis. The wide flange is overstressed by 3.29 to 1.

The maximum loading on the W6x12 beam is realized when the pallet and die are rotated directly over one of the carriage wheels, as shown above.

The die and pallet live load rating is 2000 pounds, and can be up to 29 inches from the center of rotation of the crane. The dead load of the crane itself is 1875 pounds, and is located at the point of rotation of the crane. Using AISC-LRFD design procedures, the factored live load, including a 10% allowance for impact (Section A-4.1 and A-4.2) is

P2 is the maximum calculated wheel load, which is 1" off-center. PL is the equivalent lateral load which gives the same torsional twist to the beam as did P2, when P2 is moved to a direct shear position. This lateral load causes significant bending about the weak axis of the beam, as shown in the calculations below.
