# William LeMessurier - The Fifty-Nine-Story Crisis: A Lesson in Professional Behavior

William LeMessurier served as design and construction consultant on the innovative Citicorp headquarters tower, which was completed in 1977 in New York. The next year, after a college student studying the tower design had called him to point out a possible deficiency, LeMessurier discovered that the building was indeed structurally deficient.

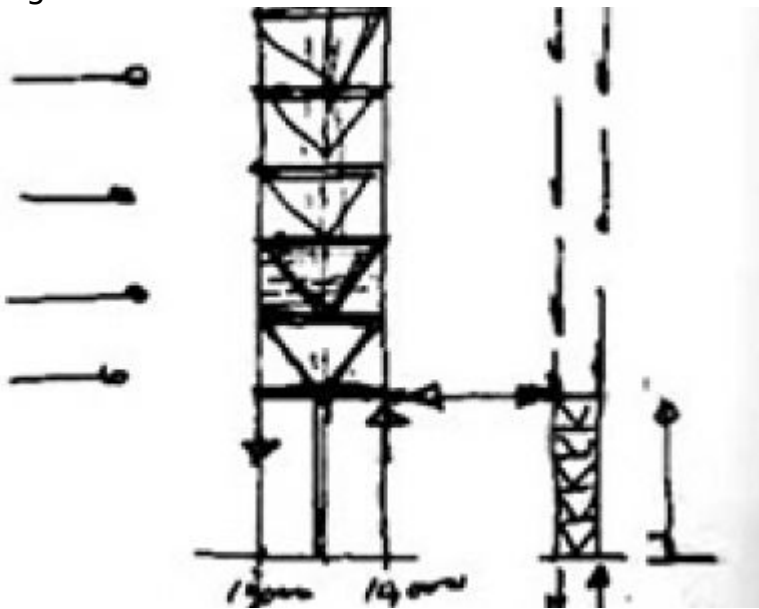
LeMessurier's experience with innovative designs was fortunate, since there was a criterion peculiar to the planned Citibank building. A church had partial ownership of the block where Citicorp planned to build. As a resolution, Citicorp agreed to build a new free-standing structure, located at one corner of the lot, to replace the current antiquated, dilapidated church. In return, the church granted "air rights" above its part of the block to Citicorp. *(Pictured: The bottom part of the first rendering of the Citicorp tower design, clearly showing the nine-story high, mid-wall-mounted stilts that would need to support the building.)*

In order to provide space for the new church, the Citicorp tower would therefore have to be situated on nine-story-high stilts, so the church could be constructed underneath. However, the church was to be located at a corner of the block, not in the middle of a block. This meant that the Citicorp tower's stilts would have to be in the middle of each of its walls, and not at the building's corners -- an unprecedented feat of engineering if it could be accomplished.

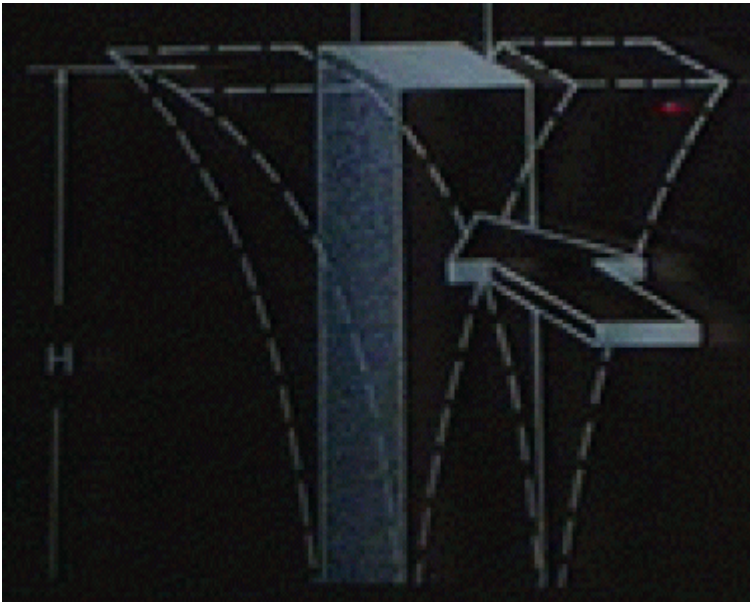
The professor had not understood the design problem that had been faced, so LeMessurier explained his entire line of reasoning for putting the tower's supports at the building's midpoints. He added that his unique design, including the supports and the diagonal-brace system, made the building particularly resistant to quartering, or diagonal, winds -- that is, winds coming on the diagonal and so hitting two sides of the building simultaneously. Pictured is a diagram of why perpendicular winds cause sway in a building.

Interested to see if the building's diagonal braces would be as strong in quartering winds as they had been calculated to be in perpendicular winds, LeMessurier did some computations. He found that for a given quartering wind, stresses in half of a certain number of structural members increased by 40 percent.
