William LeMessurier - The Fifty-Nine-Story Crisis: A Lesson in Professional Behavior

William LeMessurier served as design and construction consultant on the innovative Citicorp headquarters tower, which was completed in 1977 in New York. The next year, after a college student studying the tower design had called him to point out a possible deficiency, LeMessurier discovered that the building was indeed structurally deficient.

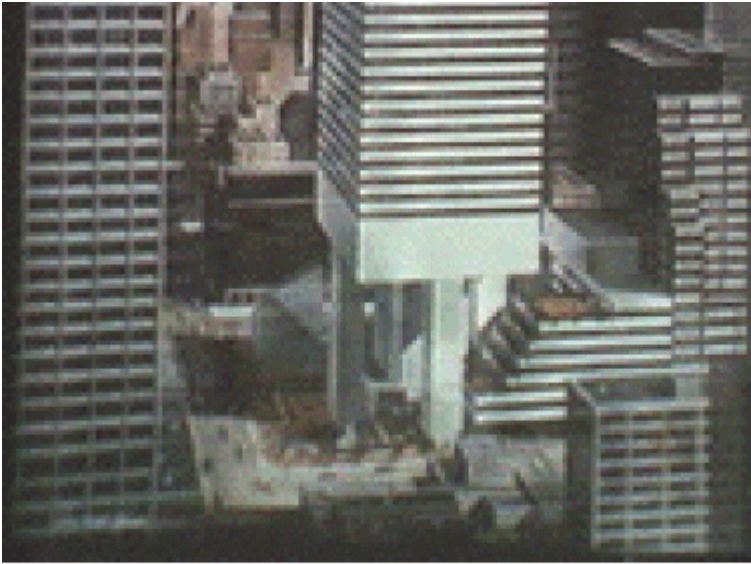
Photo of Citicorp Tower

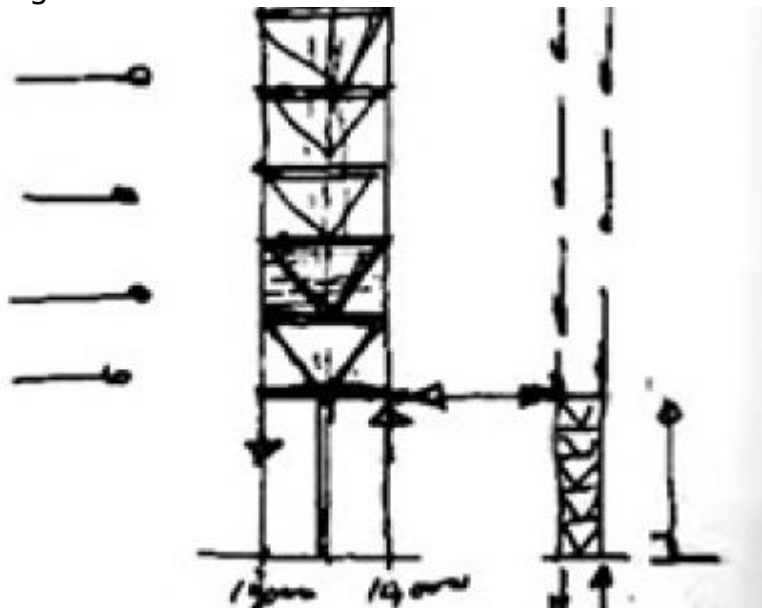
LeMessurier's experience with innovative designs was fortunate, since there was a criterion peculiar to the planned Citibank building. A church had partial ownership of the block where Citicorp planned to build. As a resolution, Citicorp agreed to build a new free-standing structure, located at one corner of the lot, to replace the current antiquated, dilapidated church. In return, the church granted "air rights" above its part of the block to Citicorp. *(Pictured: The bottom part of the first rendering of the Citicorp tower design, clearly showing the nine-story high, mid-wall-mounted stilts that would need to support the building.)*

In order to provide space for the new church, the Citicorp tower would therefore have to be situated on nine-story-high stilts, so the church could be constructed underneath. However, the church was to be located at a corner of the block, not in the middle of a block. This meant that the Citicorp tower's stilts would have to be in the middle of each of its walls, and not at the building's corners -- an unprecedented feat of engineering if it could be accomplished.

The innovative LeMessurier sketched an idea for the Citicorp tower's framework and column support system. It called for large diagonal girders throughout the building. The girders would transfer the tower's great weight to the four huge columns that would anchor the structure to the ground. The new church could then be constructed as planned, underneath one of the tower's corners.

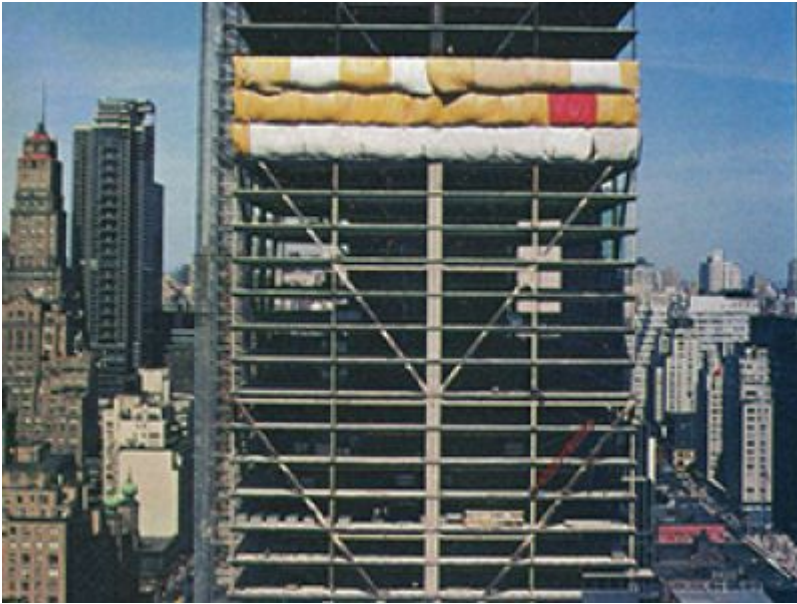
Unknown to LeMessurier, however, was that during the Citicorp tower's construction (*the tower under construction is pictured on this page*), the Citicorp contractors had decided, based on the cost of welding, to put the braces together using less expensive bolted joints. Though bolted joints were weaker than welded joints, the New York contractors had agreed that welds would be unnecessarily strong and that bolts would be sufficient for the job.

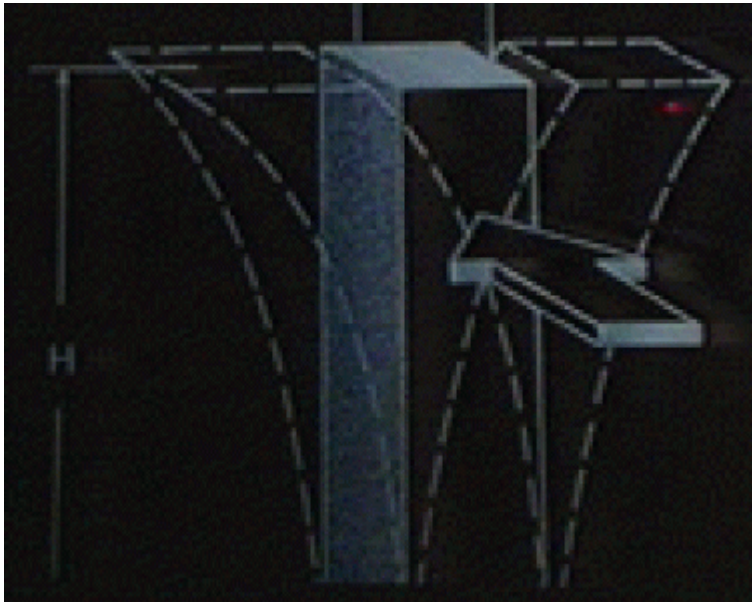
The professor had not understood the design problem that had been faced, so LeMessurier explained his entire line of reasoning for putting the tower's supports at the building's midpoints. He added that his unique design, including the supports and the diagonal-brace system, made the building particularly resistant to quartering, or diagonal, winds -- that is, winds coming on the diagonal and so hitting two sides of the building simultaneously. Pictured is a diagram of why perpendicular winds cause sway in a building.

Interested to see if the building's diagonal braces would be as strong in quartering winds as they had been calculated to be in perpendicular winds, LeMessurier did some computations. He found that for a given quartering wind, stresses in half of a certain number of structural members increased by 40 percent.
