# William LeMessurier - The Fifty-Nine-Story Crisis: A Lesson in Professional Behavior

William LeMessurier served as design and construction consultant on the innovative Citicorp headquarters tower, which was completed in 1977 in New York. The next year, after a college student studying the tower design had called him to point out a possible deficiency, LeMessurier discovered that the building was indeed structurally deficient.

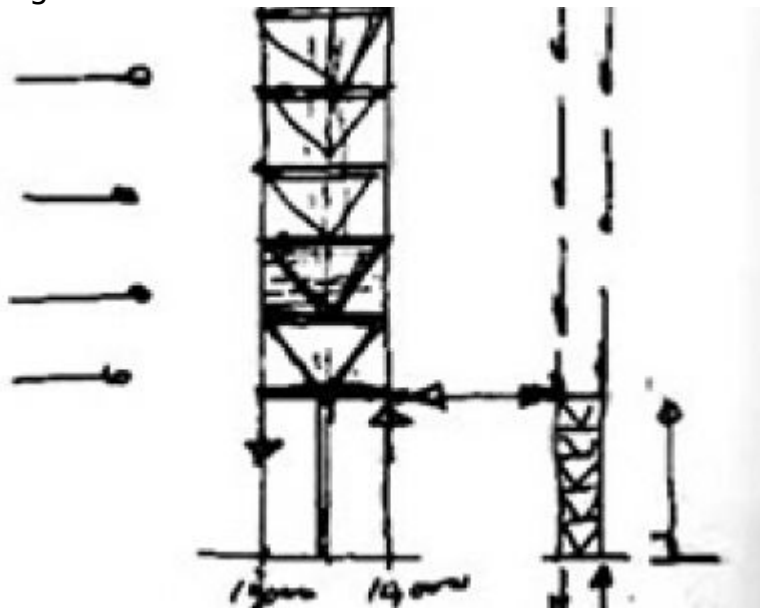
LeMessurier's experience with innovative designs was fortunate, since there was a criterion peculiar to the planned Citibank building. A church had partial ownership of the block where Citicorp planned to build. As a resolution, Citicorp agreed to build a new free-standing structure, located at one corner of the lot, to replace the current antiquated, dilapidated church. In return, the church granted "air rights" above its part of the block to Citicorp. *(Pictured: The bottom part of the first rendering of the Citicorp tower design, clearly showing the nine-story high, mid-wall-mounted stilts that would need to support the building.)*

In order to provide space for the new church, the Citicorp tower would therefore have to be situated on nine-story-high stilts, so the church could be constructed underneath. However, the church was to be located at a corner of the block, not in the middle of a block. This meant that the Citicorp tower's stilts would have to be in the middle of each of its walls, and not at the building's corners -- an unprecedented feat of engineering if it could be accomplished.

The innovative LeMessurier sketched an idea for the Citicorp tower's framework and column support system. It called for large diagonal girders throughout the building. The girders would transfer the tower's great weight to the four huge columns that would anchor the structure to the ground. The new church could then be constructed as planned, underneath one of the tower's corners.
