Online Ethics Center
FOR ENGINEERING AND SCIENCE

William LeMessurier - The Fifty-Nine-Story Crisis: A Lesson in Professional Behavior

The Story of the Citicorp Tower

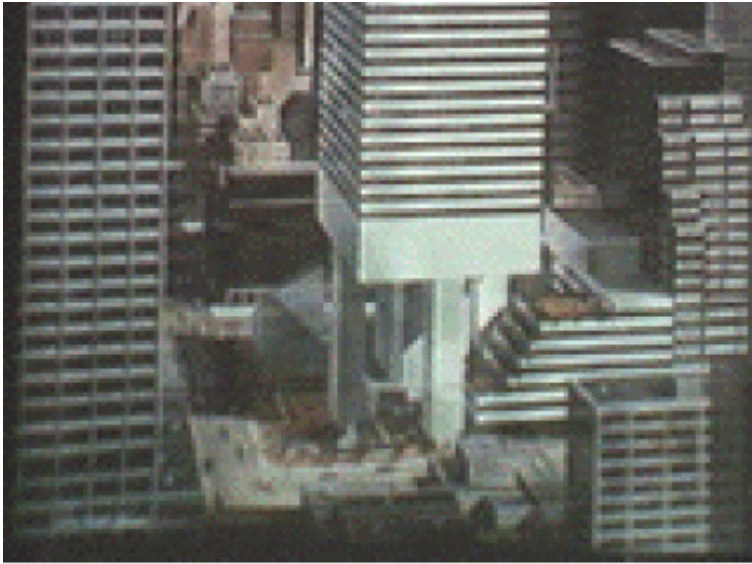
Photo of Citicorp Tower

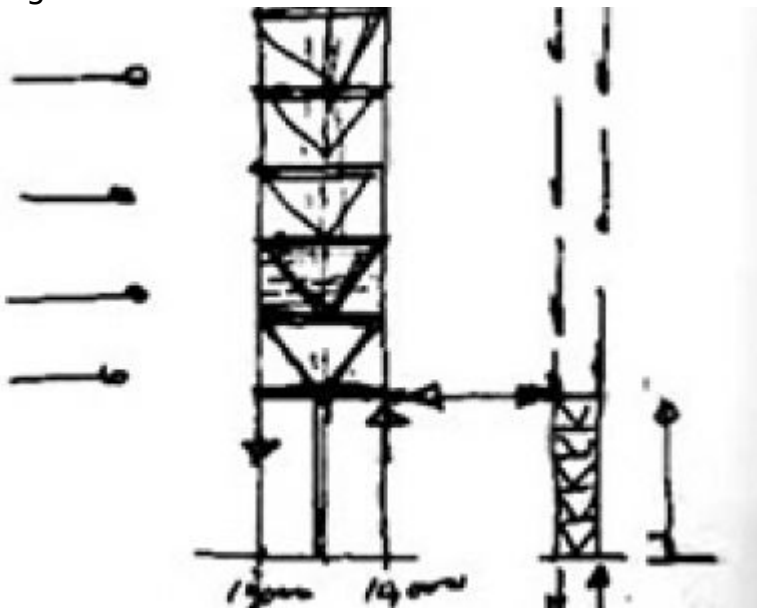
LeMessurier's experience with innovative designs was fortunate, since there was a criterion peculiar to the planned Citibank building. A church had partial ownership of the block where Citicorp planned to build. As a resolution, Citicorp agreed to build a new free-standing structure, located at one corner of the lot, to replace the current antiquated, dilapidated church. In return, the church granted "air rights" above its part of the block to Citicorp. *(Pictured: The bottom part of the first rendering of the Citicorp tower design, clearly showing the nine-story high, mid-wall-mounted stilts that would need to support the building.)*

In order to provide space for the new church, the Citicorp tower would therefore have to be situated on nine-story-high stilts, so the church could be constructed underneath. However, the church was to be located at a corner of the block, not in the middle of a block. This meant that the Citicorp tower's stilts would have to be in the middle of each of its walls, and not at the building's corners -- an unprecedented feat of engineering if it could be accomplished.

The innovative LeMessurier sketched an idea for the Citicorp tower's framework and column support system. It called for large diagonal girders throughout the building. The girders would transfer the tower's great weight to the four huge columns that would anchor the structure to the ground. The [new church](#) could then be constructed as planned, underneath one of the tower's corners.

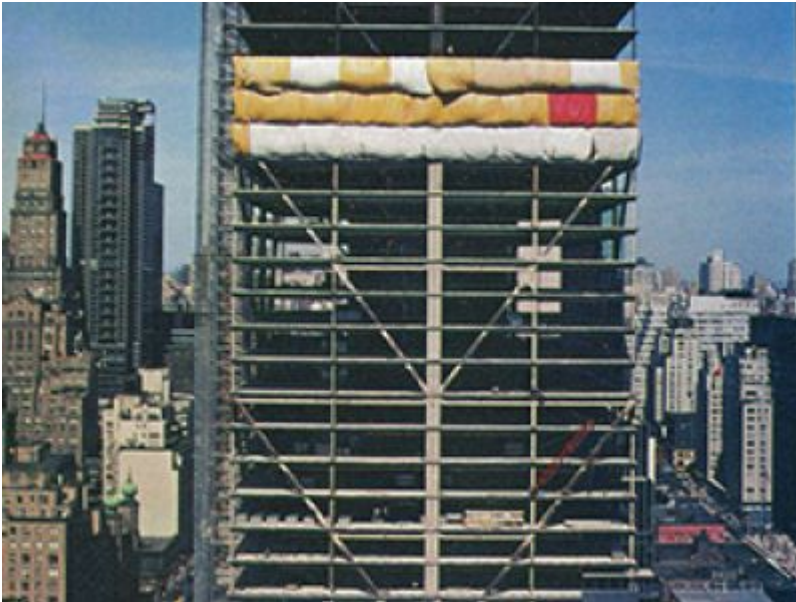
Unknown to LeMessurier, however, was that during the Citicorp tower's construction (*the tower under construction is pictured on this page*), the Citicorp contractors had decided, based on the cost of welding, to put the braces together using less expensive bolted joints. Though bolted joints were weaker than welded joints, the New York contractors had agreed that welds would be unnecessarily strong and that bolts would be sufficient for the job.

When LeMessurier referred the Pittsburgh contractor, concerned over the cost of welding, to the successful Citicorp job, he was told of the substitution of bolts for welds in the Citicorp project. LeMessurier did not consider the change to pose a safety hazard, however, since the substitution was rather reasonable from an engineering standpoint, and there wasn't any reason for LeMessurier, a distant consultant, to have been previously informed. This assessment would change over the next month, however, as LeMessurier would soon encounter new data indicating that the switch from welds to bolts compounded another danger with potentially
