The Space Shuttle Challenger Disaster

Charles E. Harris, Jr

1992

A case study looking at the explosion of the Challenger Space Shuttle.

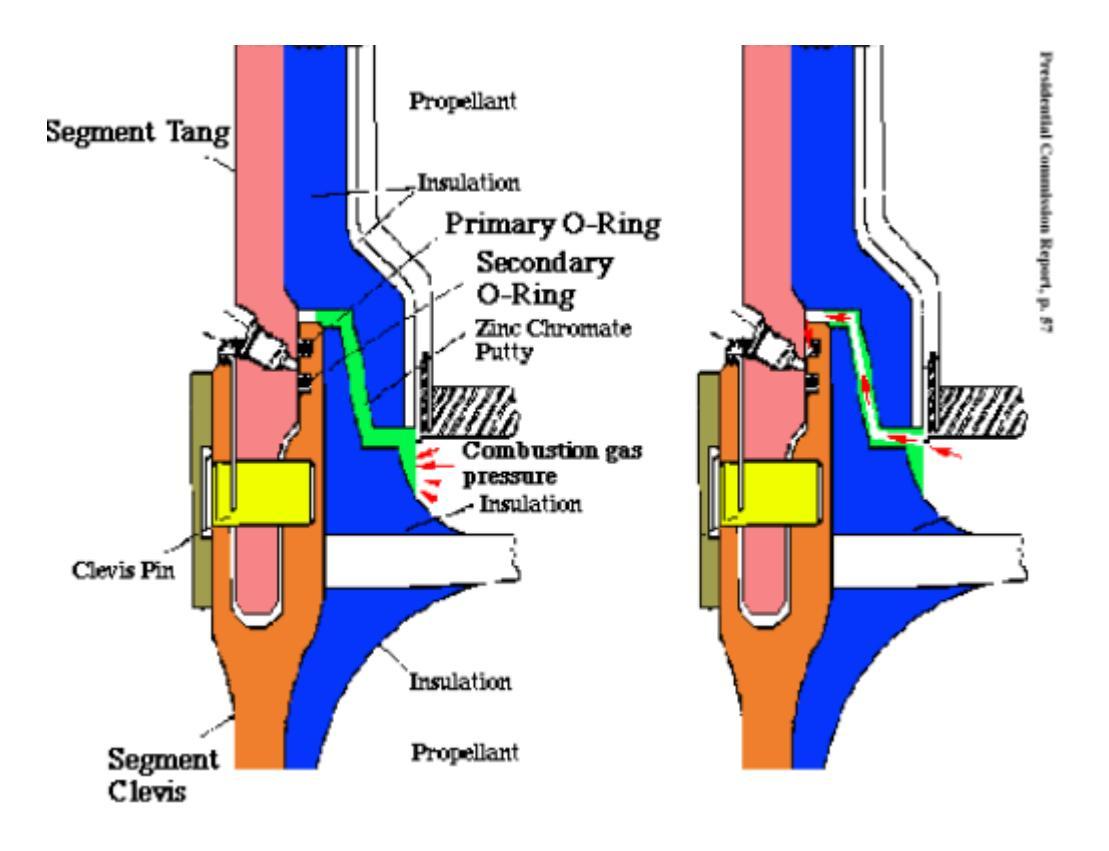
There is an SRB attached to each side of the external fuel tank. Each booster is 149 feet long and 12 feet in diameter. Before ignition, each booster weighs 2 million pounds. Solid rockets in general produce much more thrust per pound than their liquid fuel counterparts. The drawback is that once the solid rocket fuel has been ignited, it cannot be turned off or even controlled. So it was extremely important that the shuttle SRBs were properly designed. Morton Thiokol was awarded the contract to design and build the SRBs in 1974. Thiokol's design is a scaled-up version of a Titan missile which had been used successfully for years. NASA accepted the design in 1976. The booster is comprised of seven hollow metal cylinders. The solid rocket fuel is cast into the cylinders at the Thiokol plant in Utah, and the cylinders are assembled into pairs for transport to Kennedy Space Center in Florida. At KSC, the four booster segments are assembled into a completed booster rocket. The joints where the segments are joined together at KSC are known as field joints (See Figure 1).

These field joints consist of a tang and clevis joint. The tang and clevis are held together by 177 clevis pins. Each joint is sealed by two O rings, the bottom ring known as the primary O ring, and the top known as the secondary O-ring. (The Titan booster had only one O-ring. The second ring was added as a measure of redundancy since the boosters would be lifting humans into orbit. Except for the increased scale of the rocket's diameter, this was the only major difference between the shuttle booster and the Titan booster.) The purpose of the O-rings is to prevent hot combustion gasses from escaping from the inside of the motor. To provide a barrier between the rubber O-rings and the combustion gasses, a heat resistant putty is applied to the inner section of the joint prior to assembly. The gap between the tang and the clevis determines the amount of compression on the O-ring. To minimize the gap and increase the squeeze on the O-ring, shims are inserted between the tang and the outside leg of the clevis.

The size of the gap is controlled by several factors, including the dimensional tolerances of the metal cylinders and their corresponding tang or clevis, the ambient temperature, the diameter of the O-ring, the thickness of the shims, the loads on the segment, and quality control during assembly. When the booster is ignited, the putty is displaced, compressing the air between the putty and the primary O-ring.

The air pressure forces the O-ring into the gap between the tang and clevis. Pressure loads are also applied to the walls of the cylinder, causing the cylinder to balloon slightly. This ballooning of the cylinder walls caused the gap between the tang and clevis gap to open. This effect has come to be known as joint rotation. Morton-Thiokol discovered this joint rotation as part of its testing program in 1977. Thiokol discussed the problem with NASA and started analyzing and testing to determine how to increase the O-ring compression, thereby decreasing the effect of joint rotation. Three design changes were implemented:
