Case 1: Fire by Sodium Coolant Leak at Prototype Fast Breeder Reactor, Monju

Case 1 of Teaching Case Studies of Accidents in Nuclear Energy Development in Japan describes a fire caused by a massive sodium coolant leak at the Monju fast breeder reactor.

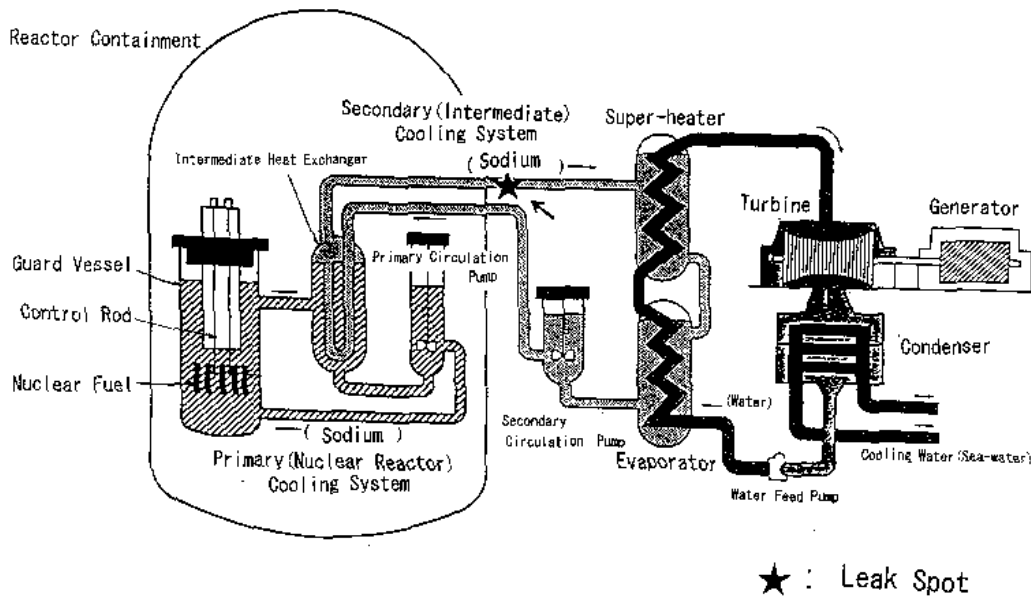
Figure 1:

Schematic Diagram of Prototype Fast Breeder Reactor, Monju

On December 8, 1995, a prototype fast breeder reactor, Monju, located in Tsuruga City, 350km west of Tokyo, was operating at 40% power⁽²⁾. The Power Reactor and Nuclear Fuel Development Corp (PNC), a government controlled organization, operated this reactor. At 19:47 high temperature liquid sodium coolant at one of the three secondary heat exchangers started leaking through a broken thermometer sheath (designed by IH Company, OD: 10mm, ID: 4mm, Length: 150mm) on the piping and it ignited on contact with air. As shown in Fig. 1, the primary heat exchangers are designed to take heat out of the core of the reactor to the secondary heat exchangers, which then transfer the heat to steam generators for

power. Because of this design, it was a simple fire caused by the leakage of chemically reactive but non-radioactive sodium coolant. But due to the delay in shutting down of the reactor, 640kg of the sodium leaked in 3 hours and caused some unexpected damage by the fire and chemical reactions to the surrounding structure.

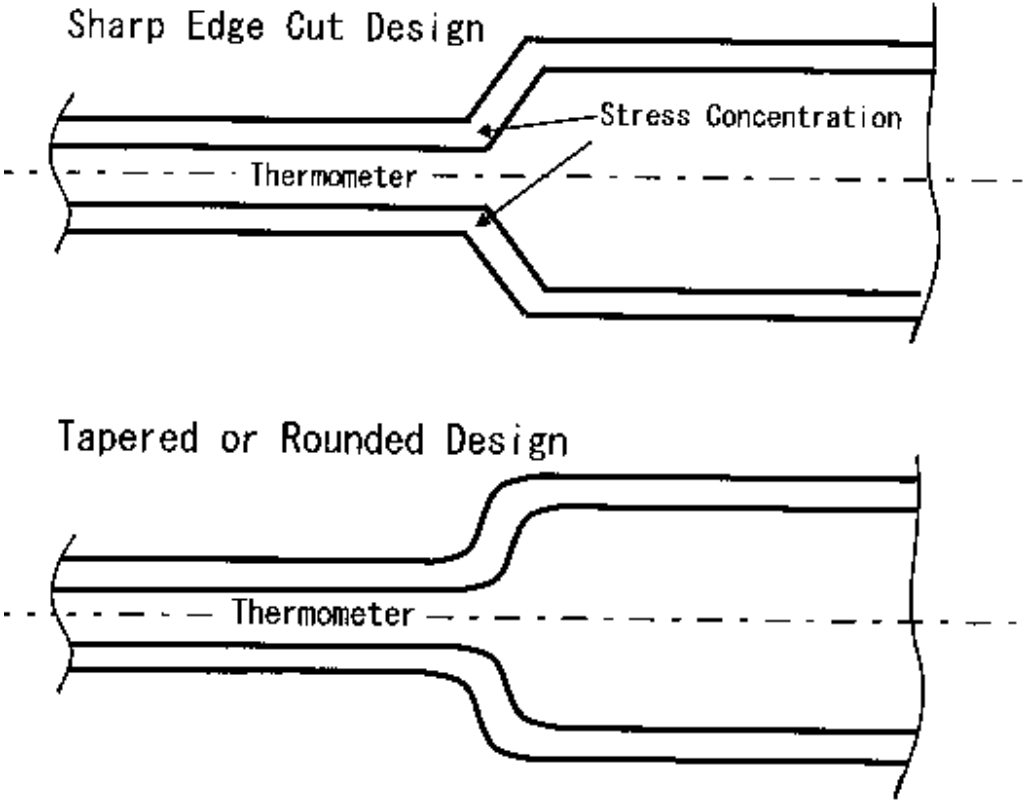
Figure 2:

The sheath was found to have been broken by following design errors such as,

1. The sharp cut edge design of the sheath as shown in Fig. 2, which caused stress concentration and breakage,
2. Neglect of newly established mechanical design analysis of vibration of the sheath parallel to the sodium flow and
3. The IH company's failure to consider the fact that liquid sodium is 120 times more heat conductive than water and to use the another contractor's (the H company's) better and simpler design for those of the primary heat exchangers. See [Fig. 3](#).

Design of Broken Thermometer Sheath (Cross Section)

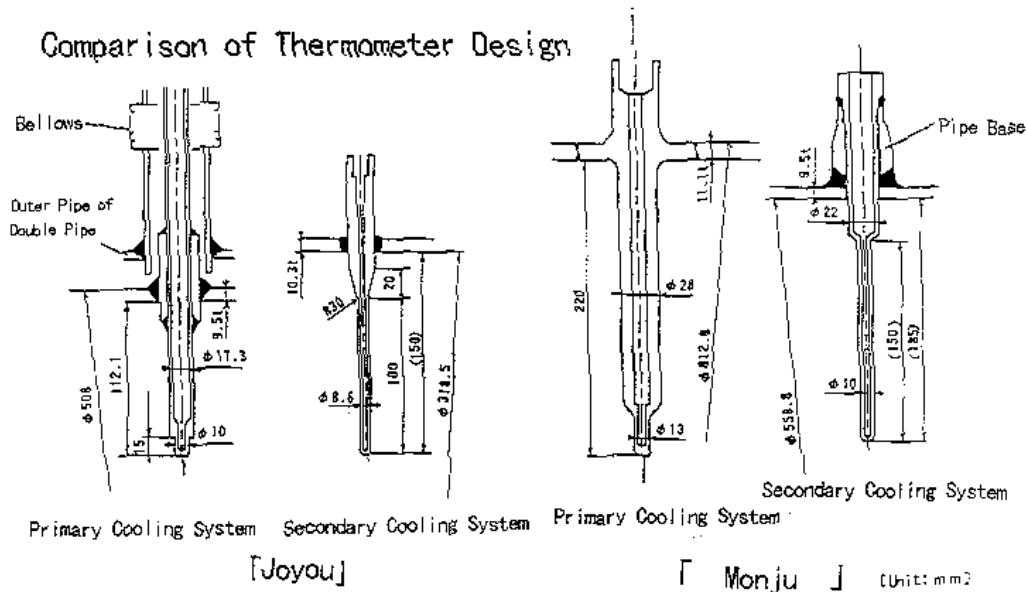
Figure 3:

Comparison of Thermometer Design
